Proceedings of the 4th Regional Symposium on

LANDSLIDES

in the Adriatic - Balkan Region

23-25 October 2019, Sarajevo, Bosnia and Herzegovina

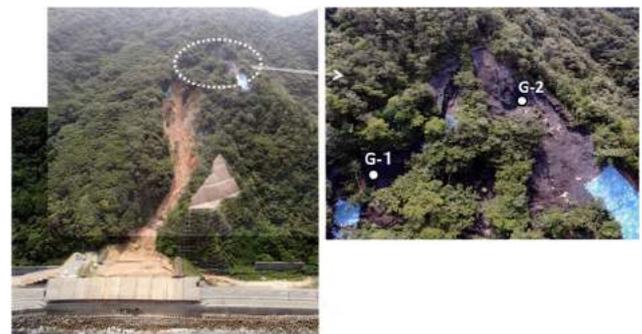
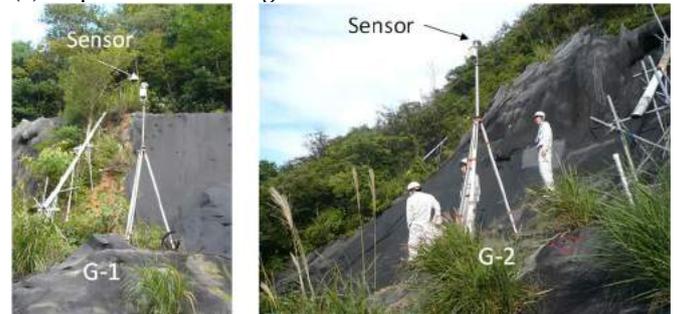
Figure 5 Monitoring site and slope beside road

(a) Slope and monitoring area

(b) GPS sensors at G-1 and G-2

The GPS displacement monitoring system (see Figure 1) was applied to monitor the displacements of an unstable steep slope along a road. Since local slope failures have occurred several times over the last 20 years, displacement monitoring has been conducted by borehole inclinometers and surface extensometers. Some of the instruments, however, have occasionally not worked well due to large displacements, and it has been difficult to perform the monitoring continuously. In order to overcome such trouble, the GPS monitoring system has been employed for continuous monitoring (Furuyama et al. 2014; Kien 2019).

Figure 5(a) presents photographs of a slope and the monitoring area. The slope is composed primarily of rhyolite and granite which formed in the Cretaceous period of the Mesozoic era, and its surface is partially covered with a colluvial deposit. The left side of the slope, as seen in the photograph in Figure 5(a), has been gradually failing over the last 20 years, and a concrete rock-shed tunnel has been constructed to cover the road and to protect it.

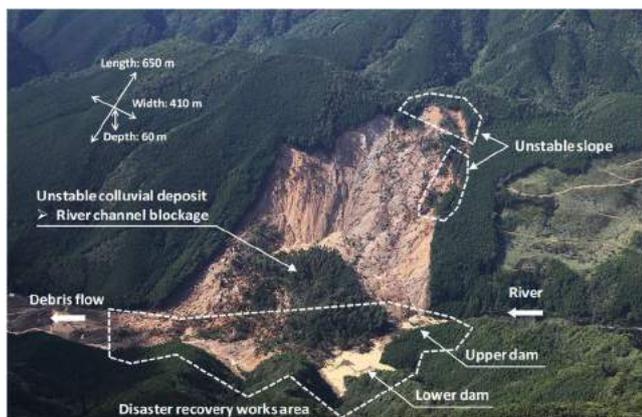
Figure 9 Landslide dam and unstable colluvial deposit (Sato et al. 2014)

A large-scale slope failure occurred in a mountainous area of Western Japan due to a heavy rainfall brought about by a typhoon. The huge volume of colluvial deposit blocked a river channel and created a landslide dam (see Figure 9). Then, a debris flow occurred due to the erosion of part of the deposit. In order to prevent the collapse of the landslide dam and the occurrence of further debris flows, disaster recovery works were carried out. The GPS monitoring system was applied to monitor the behavior of the unstable colluvial deposit (Sato et al. 2014).

The slope failure occurred over an area that was 650 m long, 410 m wide, and 60 m deep (Figure 9). The volume of the colluvial deposit was estimated to be 4.1 million m³. The slope was formed by alternating beds of sandstone and mudstone.

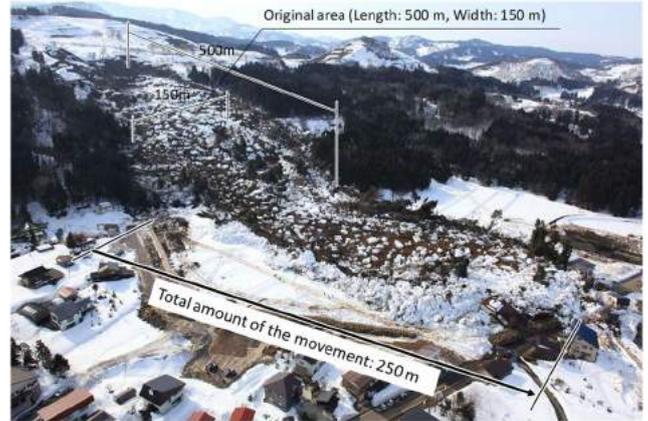
Figure 13 Landslide with a high velocity (Tosa et al. 2014)

depth, and moved down with a high velocity, namely, a maximum value of 20 m per day, to an alluvial fan with a village (see Figure 13). The GPS displacement monitoring system was applied to continuously monitor the movement in order to issue an evacuation advisory or to give orders to the local residents (Tosa et al. 2014).

The upper and lower areas of the hill are composed of mainly unconsolidated conglomerate and massive mudstone, respectively. The mass of the slope moved down along the ground surface (alluvial fan) with an inclination of only 2 degrees (see Figure 13).

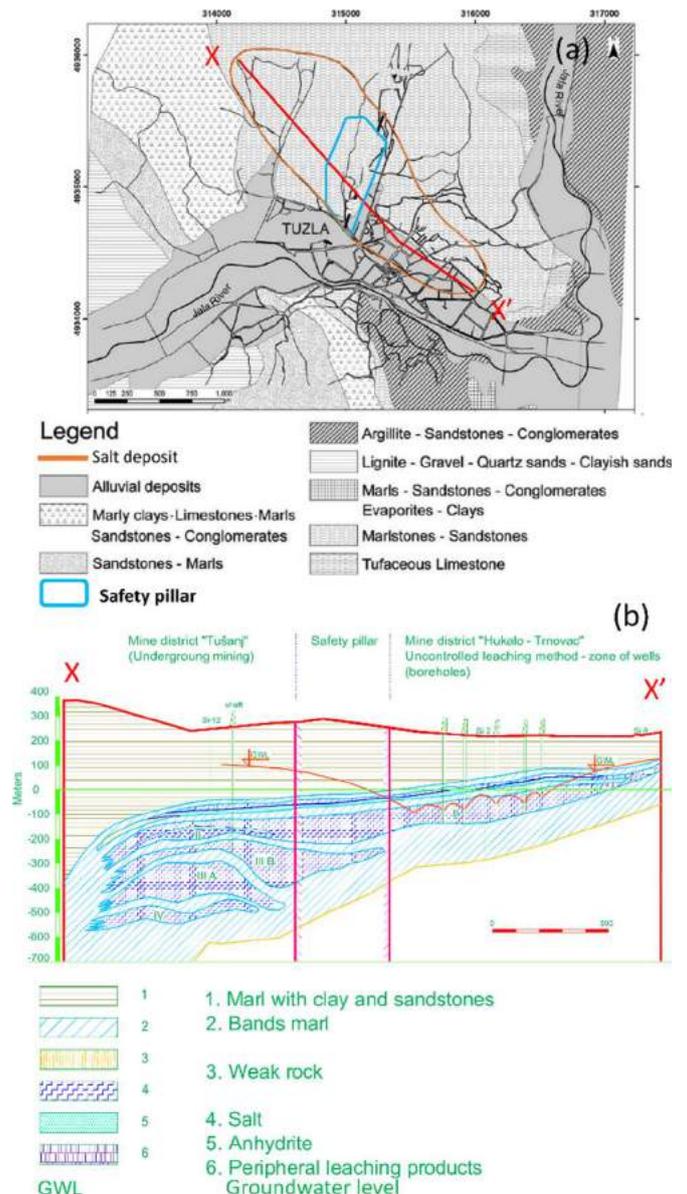
Figure 16 Geological condition of Tuzla: (a) Plan view (modified from Mancini et al. (2009a)) and (b) Vertical X-X' cross section (Parwata et al. 2019)

The total amount of subsidence during the period of 1956 to 2003 was up to 12 m, while it was more than 1 m in the area of about 2 km² of the city (Mancini et al. 2009a). The official date of termination of the salt deposit exploitation was in May 2007. However, subsidence still continued at a rate of 10-20 cm/year from 2004 to 2007 according to GPS surveys using the static method (Mancini et al. 2009b).

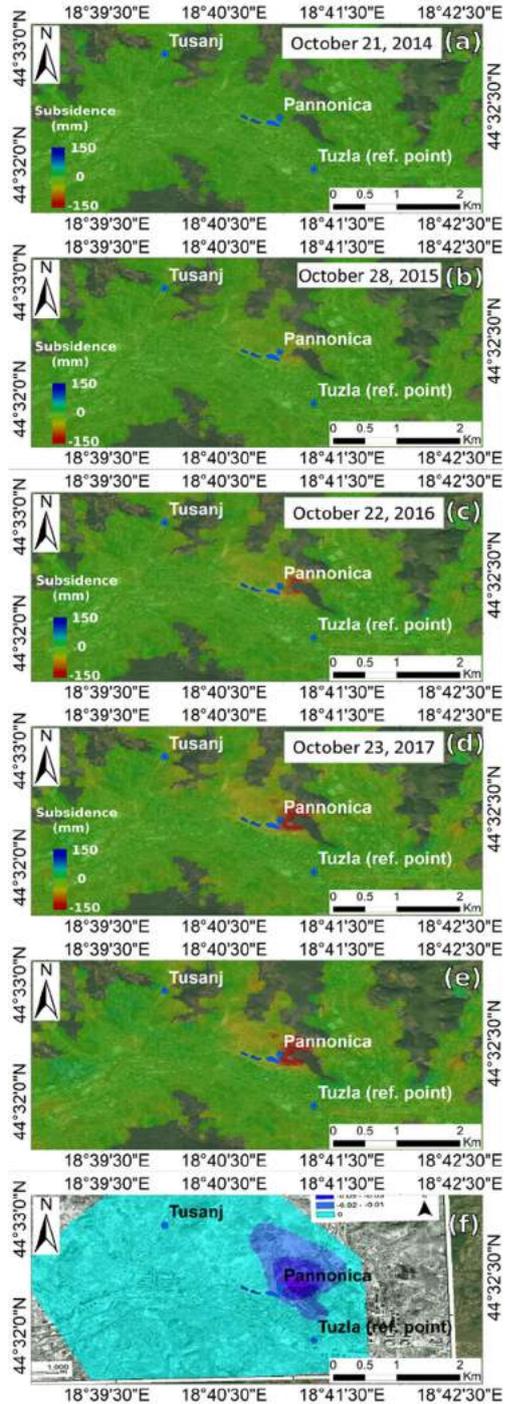
Figure 17 Subsidence distribution obtained by SBAS-DInSAR on several dates: (a) Oct. 21, 2014, (b) Oct. 28, 2015, (c) Oct. 22, 2016, (d) Oct. 23, 2017, (e) July 2, 2018, and (f) GPS results (2006 to 2007) (Parwata et al. 2019)

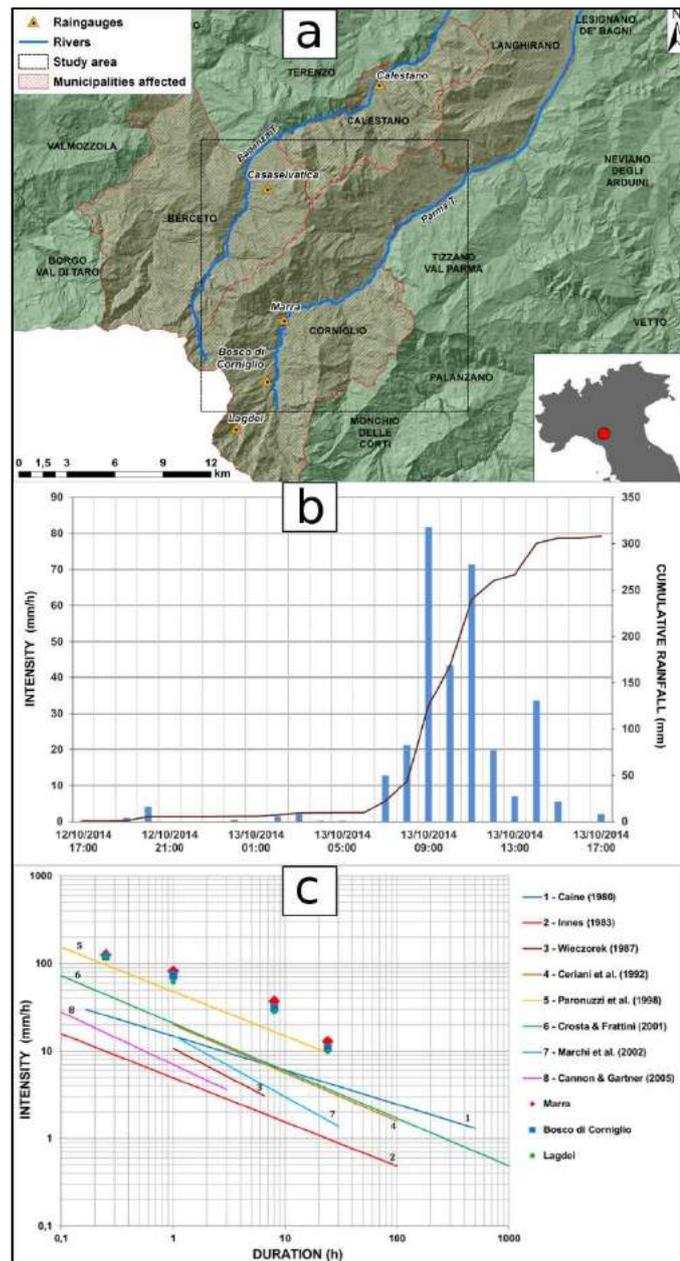
Figure 1 a) Area affected by debris flows during the Parma province alluvial event of 2014; b) rainfall data recorded by ARPAE raingauge of Marra during the alluvial event; c) comparison between rainfall data recorded by 3 raingauges and some rainfall thresholds triggering debris-flow proposed in scientific literature.

The rainfall values recorded by all rain-gauges are above the thresholds presented in scientific literature (Caine, 1980; Ceriani et al., 1992; Cannon & Gartner, 2005; Crosta & Frattini, 2001; Innes, 1983; Marchi et al., 2002; Paronuzzi et al., 1998; Wieczorek, 1987) (Fig.2c).

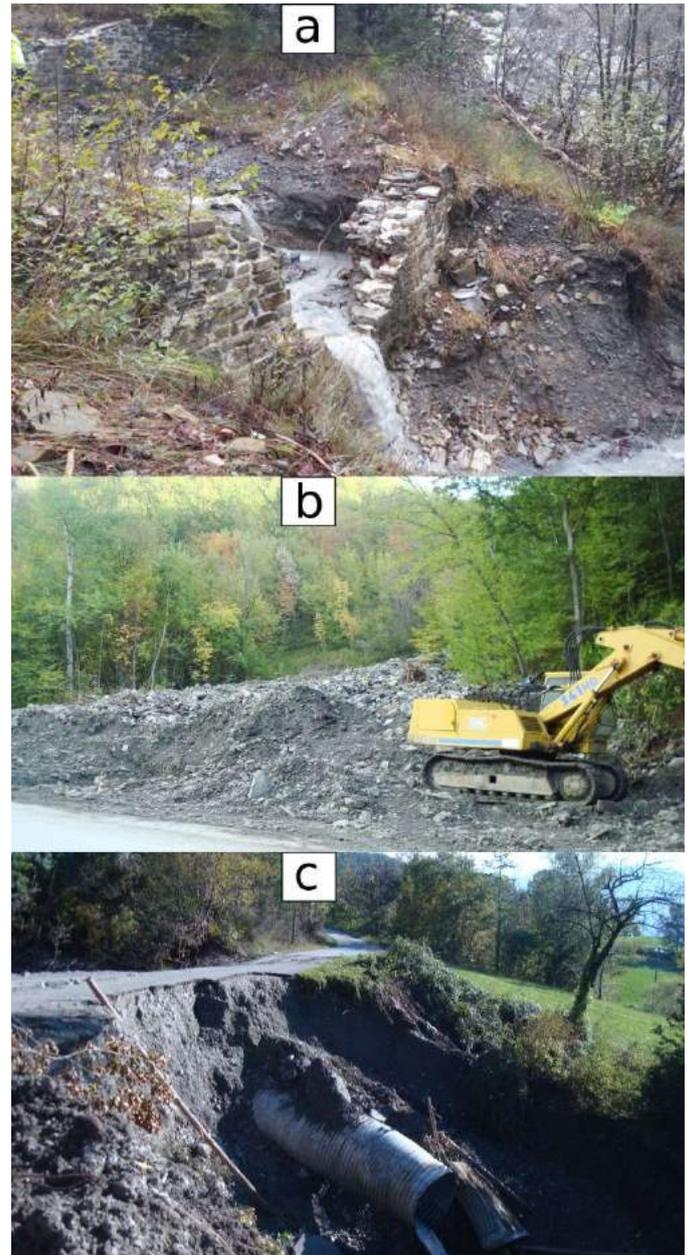
Figure 5 Example of effects on infrastructures in Parma province: a) check-dams cut-through by debris flows; b) road overrun by debris; c) erosion and cut-through of the road track.

During the Parma province alluvial event, several check dams along the torrents affected by debris flows were destroyed or buried by debris (Fig. 5a). Consequently, large amounts of debris previously trapped upstream of the check-dams, have been mobilized along the channel. Severe damages have affected many local roads crossing the debris flow tracks (Fig.5b), mostly where the torrents have been previously channeled into 1 m diameter pipes under the roads. In these cases, the flow-pipes have been rapidly obstructed by the debris flows, causing the overflow of debris and the erosion and cut-through of the road track (Fig. 5c).

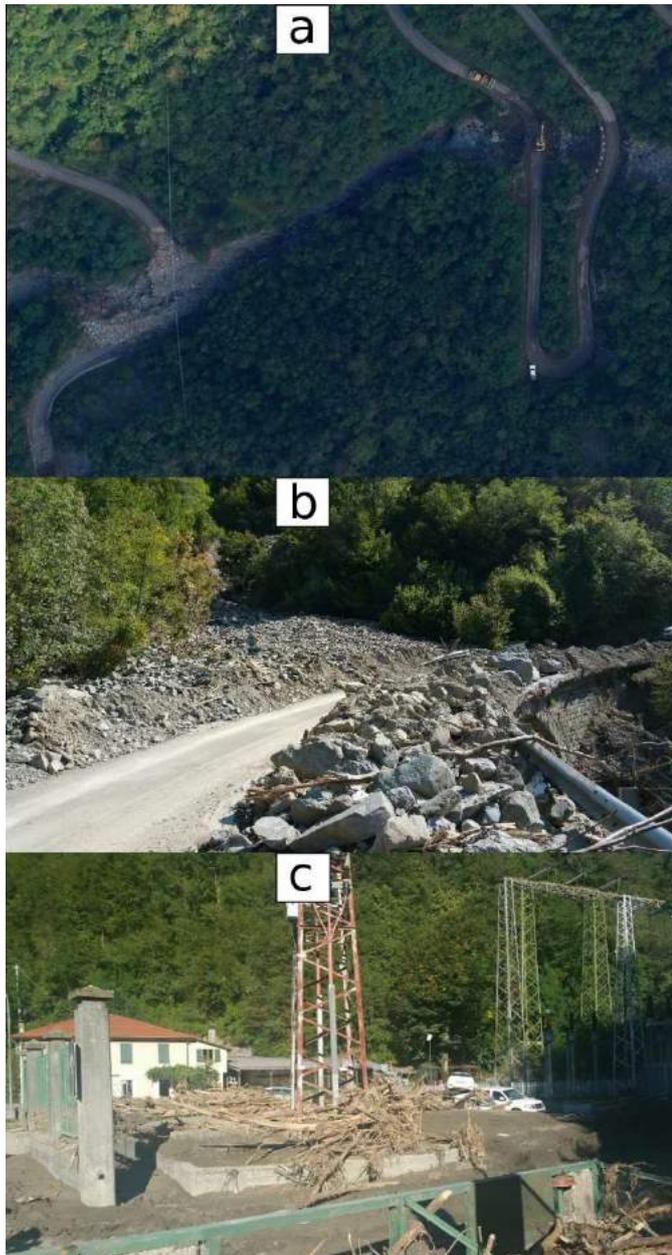
Figure 6 Example of effects on infrastructures in Piacenza province: a) aerial photo of a local road that crosses the debris flow in many sections; b) debris flow deposit along the local road; c) hydropower plant of Ruffinati overrun by debris.

Similarly, during the Piacenza province alluvial event, the most relevant damages have suffered by the roads in the points of intersection with the channels affected by debris flows. In some cases, the same road has been crossed by debris flows in several sections (Fig.6a).The accumulations of debris reached thicknesses up to 2 m (Fig.6b).

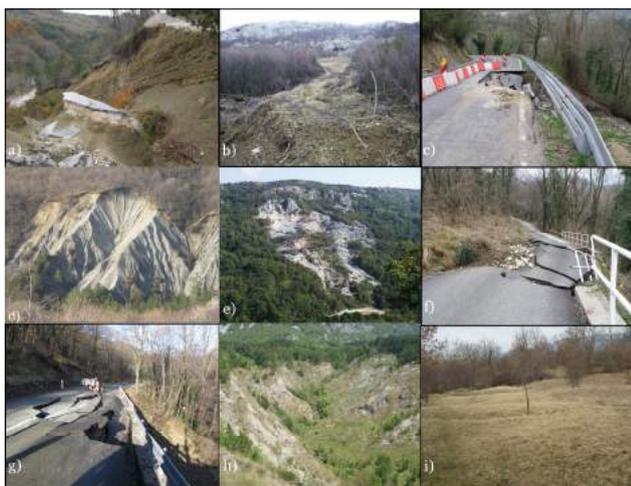
Figure 2 Landslides in the study area a) the translational landslide Brus, b) a debris flow Krbavčiči, c) the rotational landslide Marinci, d) erosion at Lesiščina in the Istrian peninsula, e) the Grohovo landslide, f) reactivated landslide Valiči, g) landslide on the Grohovo road in the Rječina river valley, h) intense erosion at Slani Potok, i) dormant landslide in the Vinodol Valley

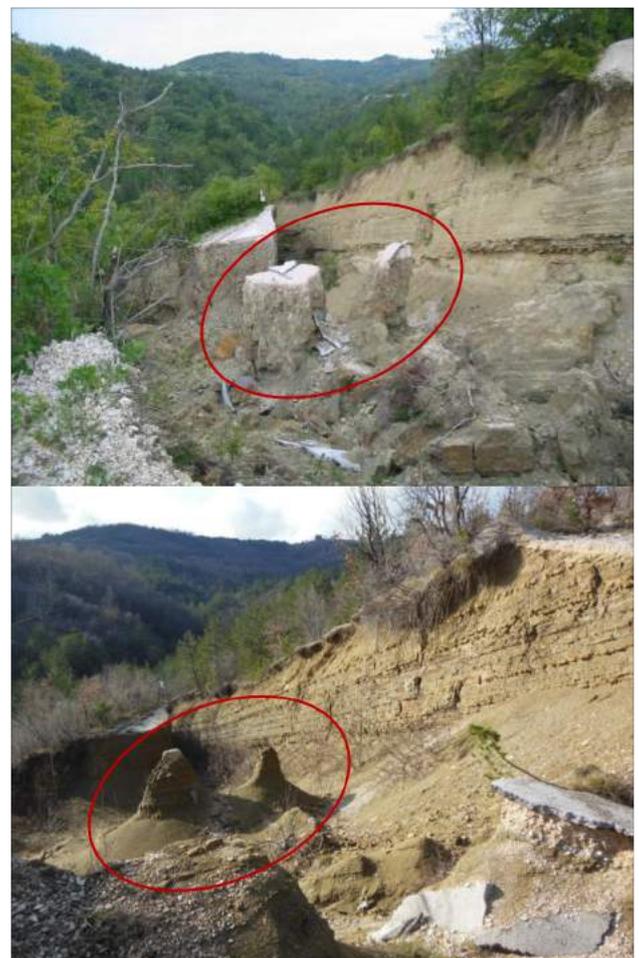
Figure 3 View of a landslide body and lateral scarp from the crown of the landslide in (a) August 2005 and (b) January 2013 (Vivoda Prodan 2016)

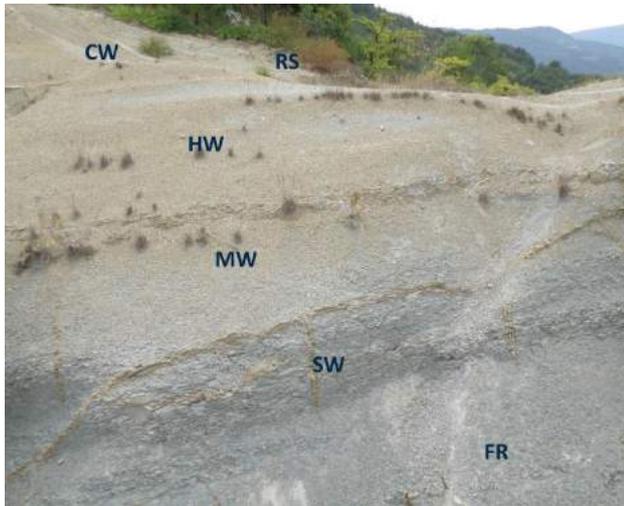
Figure 4 Examples of the weathering profile for the flysch rock mass in the Istria peninsula (Vivoda Prodan 2016)

different standard grades of siltstone were investigated in a flysch weathering profile (Figure 4): Fresh rock mass (FR); Slightly Weathered (SW), Moderately Weathered (MW), Highly Weathered (HW) and Completely Weathered (CW) rock masses; and Residual Soil (RS). Progressive and gradual weakening and decomposition takes place from the ground surface downward to fresh rock, and thus the weathering of the flysch rock material decreases from RS to CW, HW, MW, SW and FR.

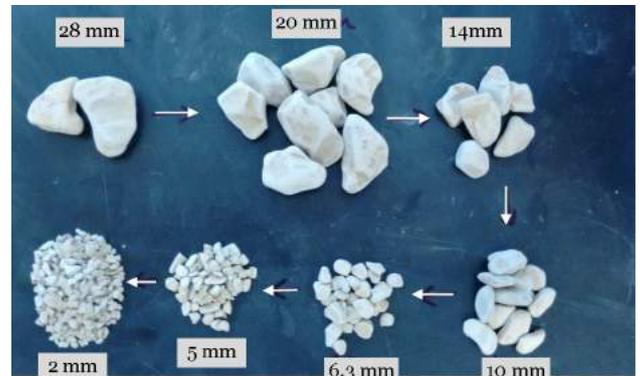
Figure 5 Fragments of FR siltstone sample taken from Istrian peninsula with various sizes retained in the drum after five cycles in the slake durability test (Vivoda Prodan 2016)

Determination of durability of siltstones using only standardized tests is not sufficient because fragmented samples of flysch rock mass acquire high slake durability index but are highly degraded (Mišćević and Vlastelica 2011, Cano and Tomás 2015, Erguler and Shakoor 2009, Cano and Tomas 2016). Figure 5 shows the sample retained in the drum that was extremely fragmented and appeared highly degraded. However, the fragments were larger than 2 mm, which led to the high I_{d2} values. However, high I_{d2} values do not correlate with this highly degraded state. Therefore, the fragment size distribution of the fragmented siltstone that was retained in the drum after each cycle of the slake durability test was quantified. Beside standardized slake durability index in the second cycle (I_{d2}), calculation of additional

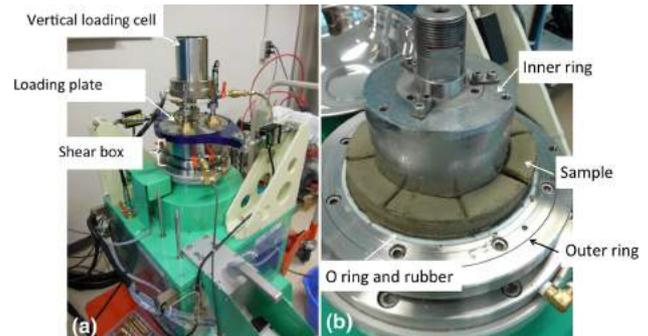
Figure 6 Siltstone sample in the ring shear device a) during and b) after testing

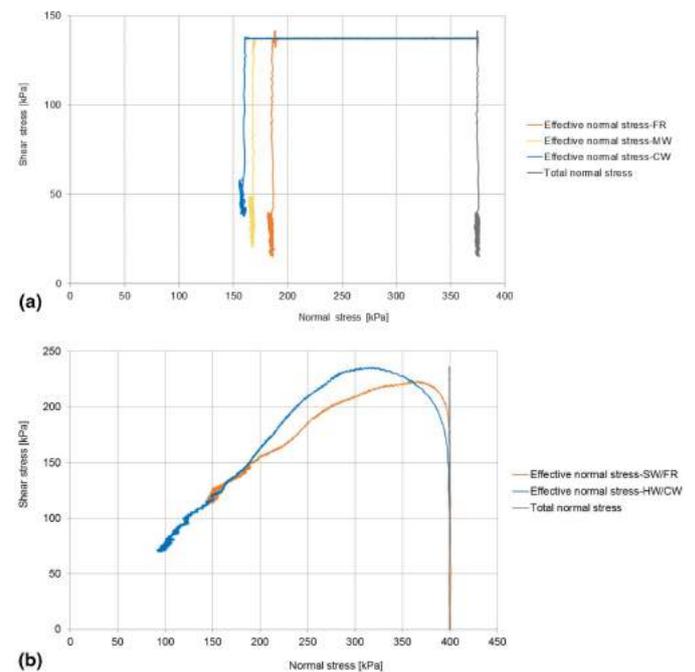
Figure 7 Normal stress-shear stress diagram based on the ring shear test for siltstone samples with different weathering grades: a) Istrian peninsula samples sheared in the pore pressure control test b) Valiči lake samples sheared in the speed control test under undrained conditions (Vivoda Prodan et al. 2016)

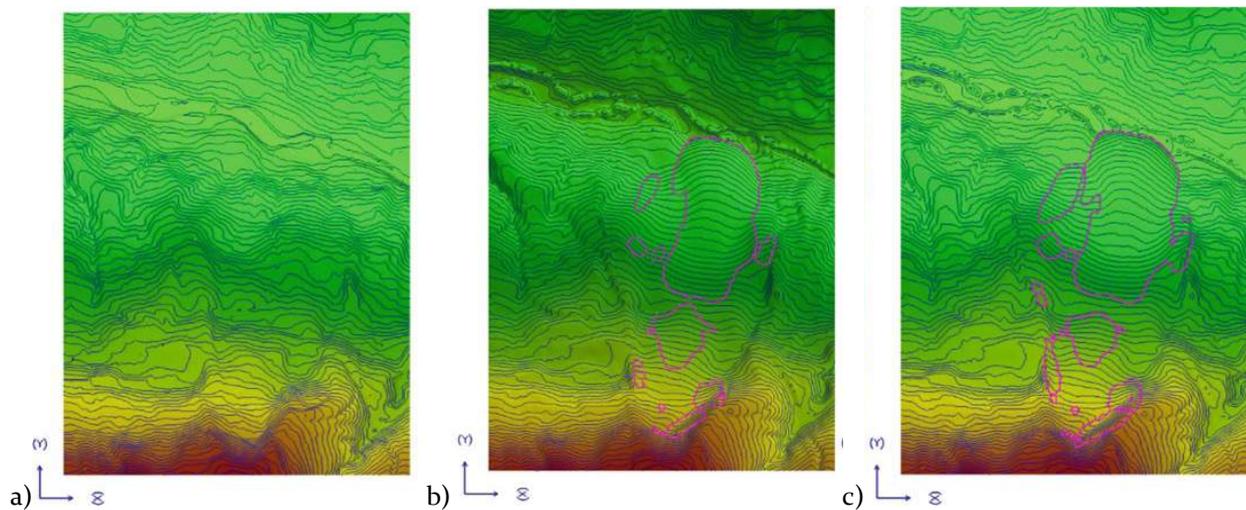
Figure 9 Top view of the terrain surface a) in the initial condition, at the end of the movement with sliding surface in b) SW/FR and c) HW/CW weathering grade of flysch rock mass (purple line shows the area of deposited landslide mass at the end of the movement) (Vivoda Prodan and Arbanas 2017)

hydrogeological conditions. Slopes built in flysch rock mass near the Rječina river valley are exposed to instabilities during raising of ground water level at different weathering grades of flysch rock mass. Landslide reactivation and filling of the Rječina river channel occurs during raising of ground water level to the ground surface. Comparison of the initial slope surface and numerical analysis results for the sliding surface in SW/FR and HW/CW weathering grade of flysch rock mass respectively is shown on Figure 9. Landslide in the slope built of more weathered flysch rock mass includes greater volume of initiated and deposited landslide mass (Figure 9c) than the slopes built in fresh or slightly weathered flysch rock mass (Figure 9b).

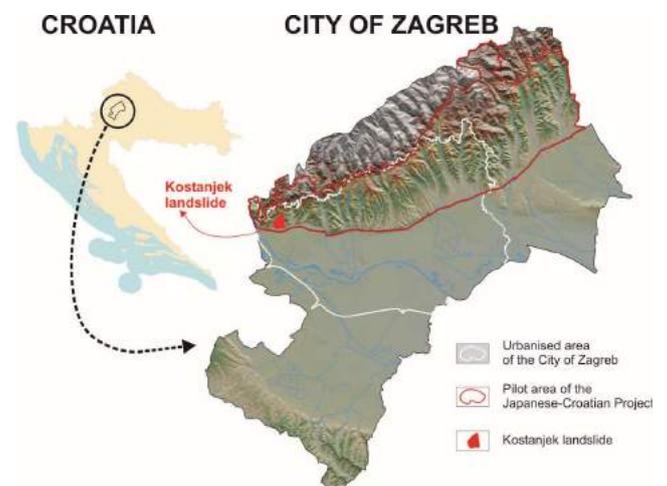
Figure 1 The Kostanjek landslide is located in the western part of the City of Zagreb and in residential area at the foot of the southwestern slope of Mt. Medvednica.

west away from the centre of city. The landslide involves an urbanized area of approximately 100 ha with a maximum length of 1250 m and a maximum width of 950 m. A volume of sliding mass is estimated approximately 32×10^6 m³ with a maximum depth of 90 m. The more detail information about the landslide is described in Stanic and Nonveiller (1996). Bedrock geology of the landslide is Miocene marly strata mainly composed of alternation of calcareous sandstone, calcareous siltstone and limestone layers. In the head to middle part of landslide, the dip of strata is 10-15 degree to south direction but the strata are inclined to North direction with 10-30 degree in the foot of the landslide. The details of geological information is described in Vrsaljko (1999), Vrsaljko et al. (2005; 2006), etc. Hydrochemical investigation was also carried out in this area (e.g., Watanabe et al., 2012).

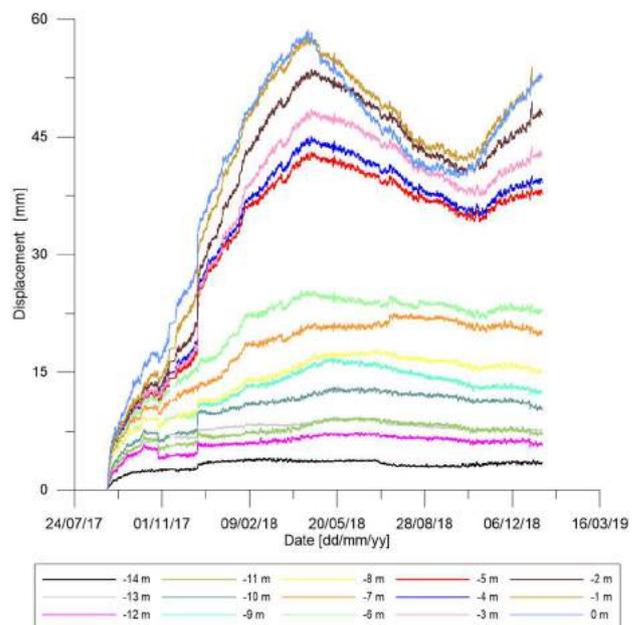
Figure 5 Cumulative displacement trend over time, recorded by DT0080 MEMS.

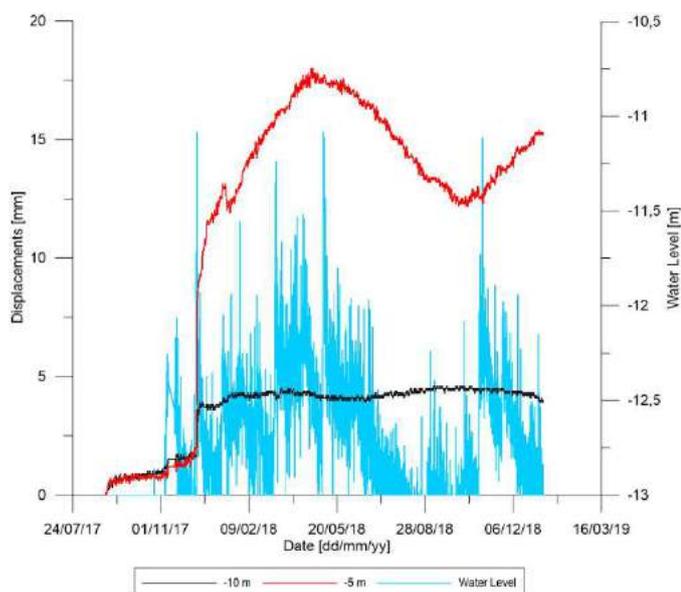
Figure 6 Water level variation measured by Piezo Link installed on DT0080, together with local displacements recorded at -5 m and -10 m.

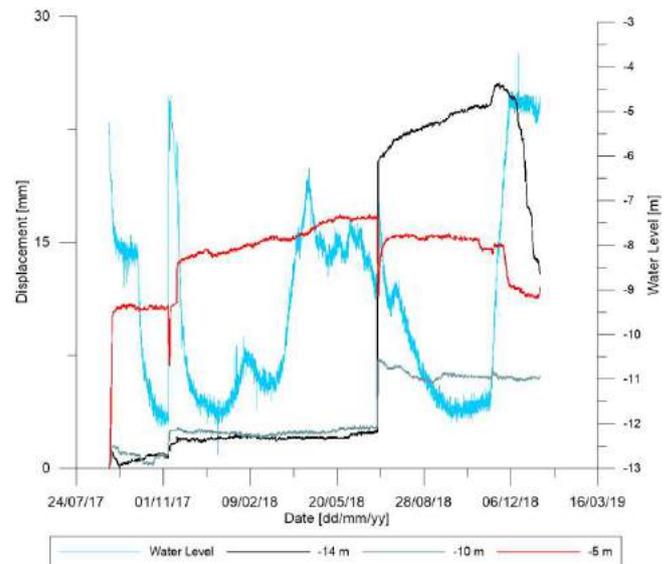
Figure 11 Water level variation measured by Piezo Link installed on DT0081, together with local displacements recorded at -5 m, -10 m and -14 m.

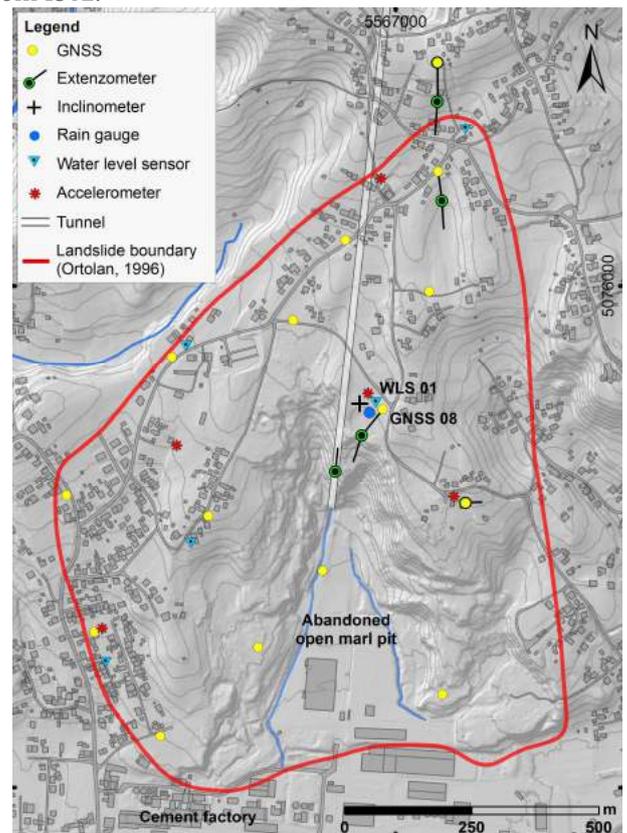
Figure 2 Locations of multiple sensor networks at the Kostanjek landslide (Krkač et al, 2017).

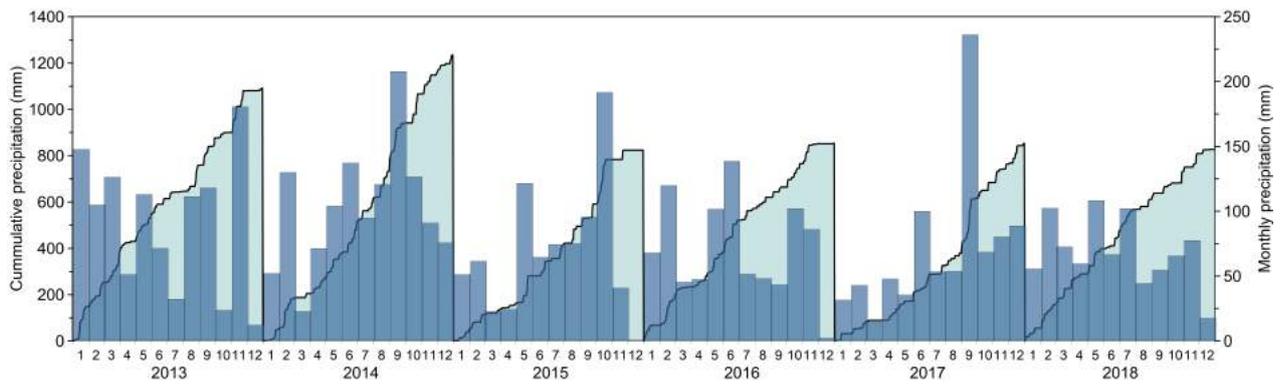
Figure 3 Cumulative and monthly precipitations measured at Zagreb-Grič meteorological station

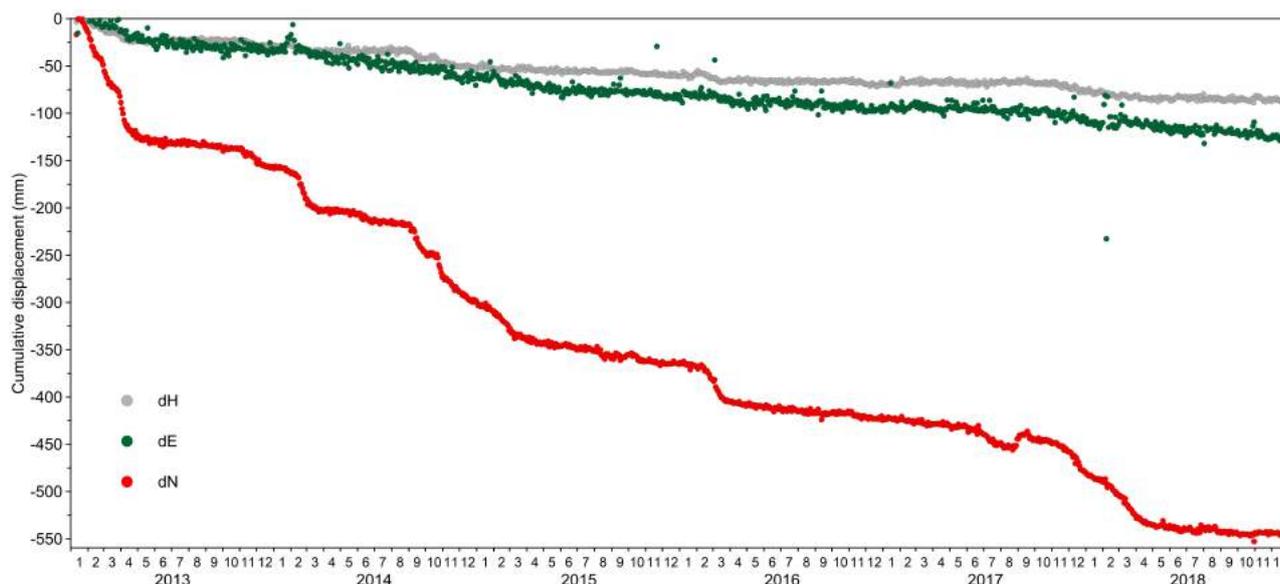
Figure 5 Cumulative displacements measured at the central part of landslide (GNSS o8).

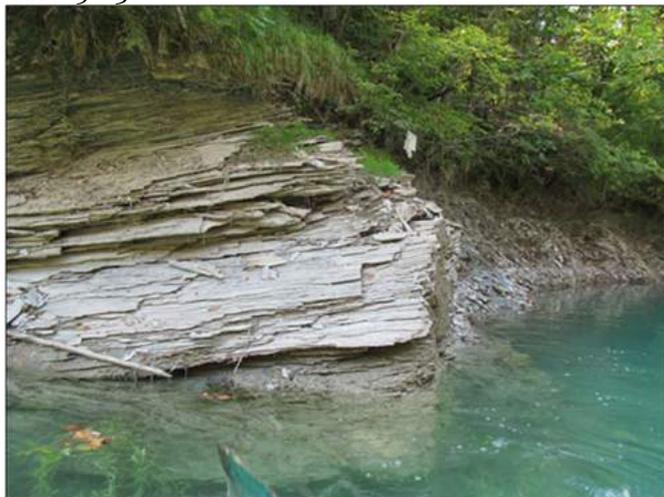
Figure 4 Basic rock on the lake of Jablanica coast (photo, Nikolic T. 2018.)

The basic material on this location is shale alevrites. Due to the layers and the position of cleavage a typical disintegration “brill” shape can be seen which is characteristic of atmospheric forces affecting this type of stone. Small layers of sandstone and limestone inside of the rock base of 1-2 cm thickness can be seen in the surrounding profiles. The material is very sensitive to porosity and has low geomechanical properties, however, if isolated from the atmospheric impact, it can be in a stable condition. In Fig 4, a fresh cut on the other side of the lake coast is shown. The GSI value obtained after the visual inspection of the stone on the field is shown in Fig.3. The condition of the surface layer is of very poor quality and becoming even poorer during rainfall and due to the sun impact, some disintegration of the material is evident as well (where limestone and sandstone layers are located) GSI = 5 – 30.

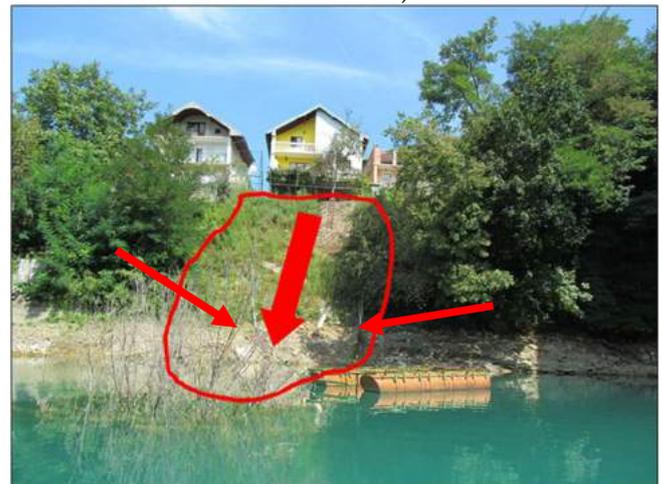
Figure 5 The current situation on the field (Nikolic T. 2018)

After the activation of the slope, the same water was directed by a pipeline to the bottom of the slope (Fig. 5).

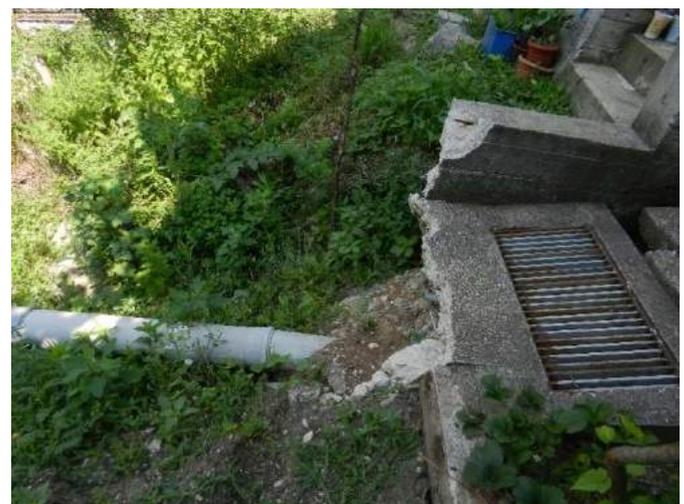
Figure 6 Fracture of the concrete wall below the house (Nikolic T. 2018)

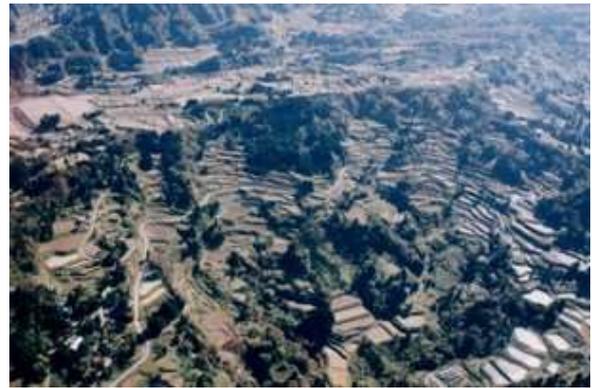
Figure 4 Landslides in Neogene formation

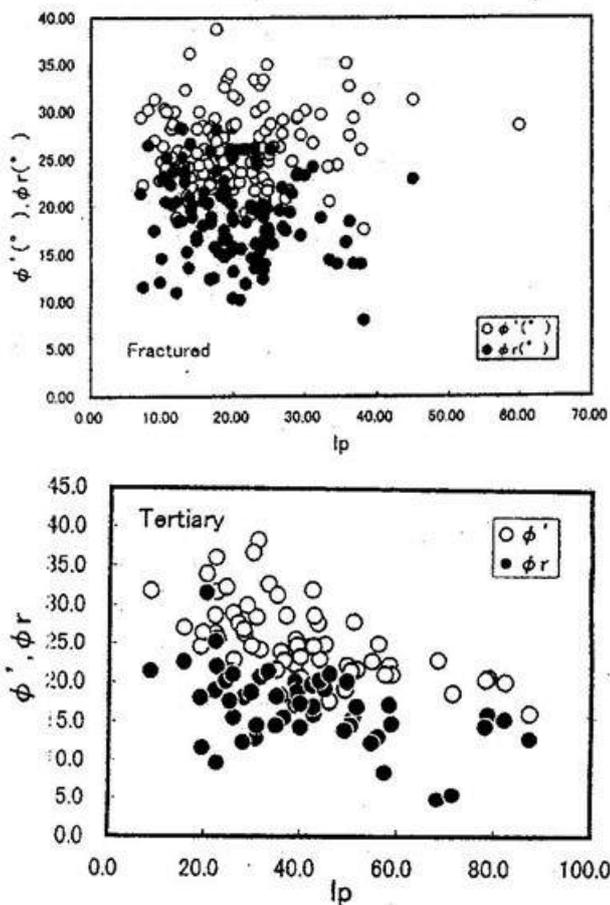
Figure 8 Relationship between peak strength ϕ' or residual strength ϕ_r and plasticity index I_p in landslides in fractured metamorphic rock formation and in landslides in Neogene formation (Yatabe et.al., 2000)

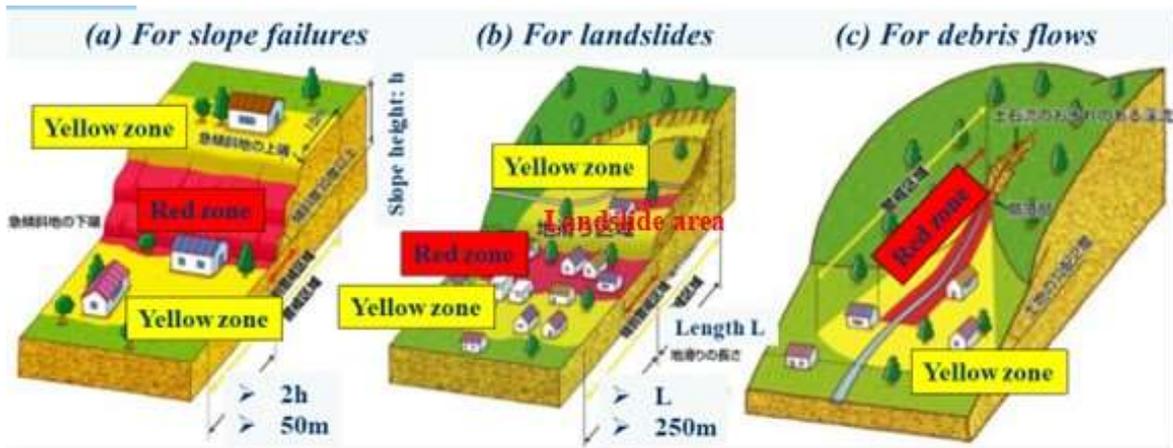
Figure 13 Schematic representation of „hazard zoning“ for three processes (Ministry of Land, Infrastructure and Transport, 2014)

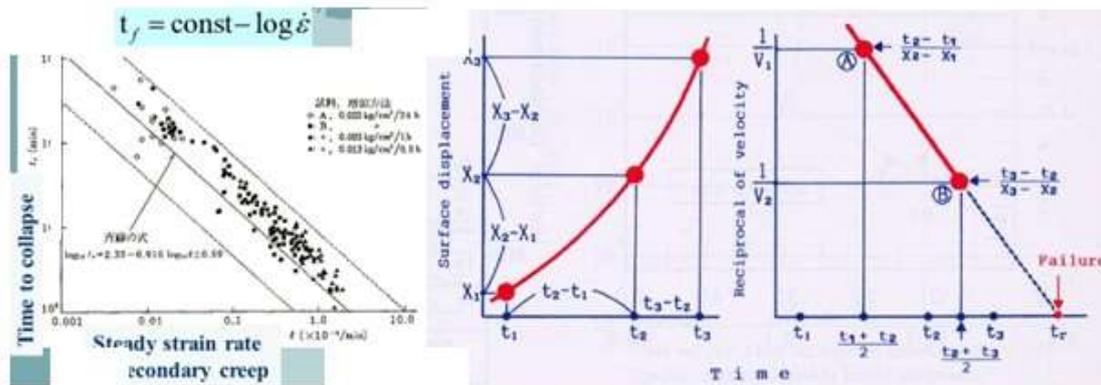
Figure 14 Left: Diagram illustrating method by Saito; Right: Diagram illustrating method by Fukuzono

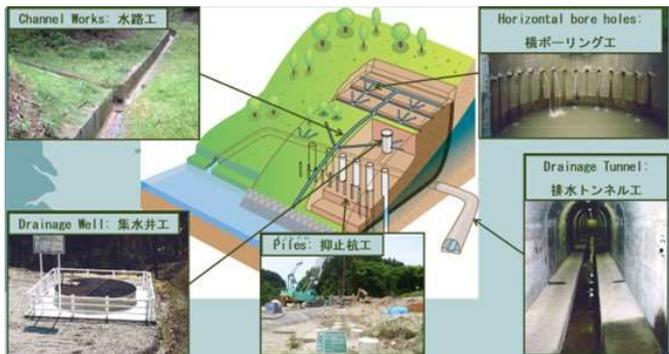
Figure 17 Illustration of various types of landslide mitigation measures (Agano River District Office, 2016)

Hard measures are classified into two types; namely „landslide control measures“, and „landslide restraint measures“. Landslide control measures involve modifications of the natural conditions of landslide areas such as topography, groundwater and other conditions that indirectly control the landslide movement. Landslide restraint measures, on the other hand, rely on preventing the landslide movement by directly adding a resisting force to the sliding movement. Individual measures included in both types of mitigation measures are listed in Fig. 16, and examples shown in Figs. 17 to 19.

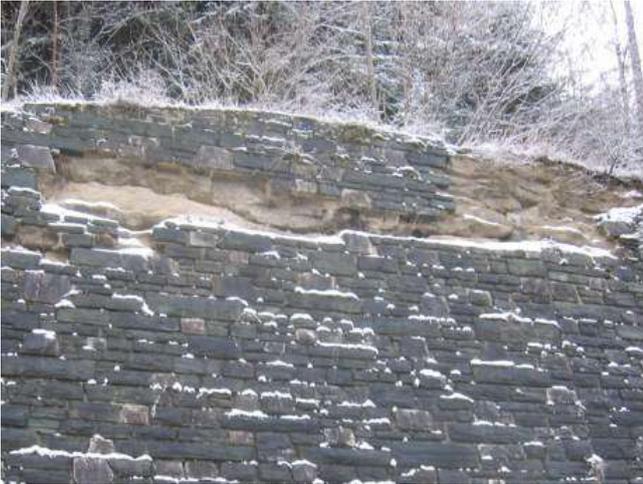
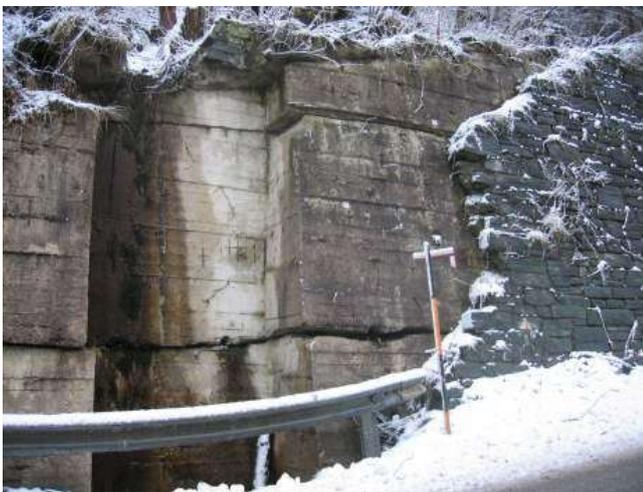
Figure 2 Damage to retaining walls along "old" route

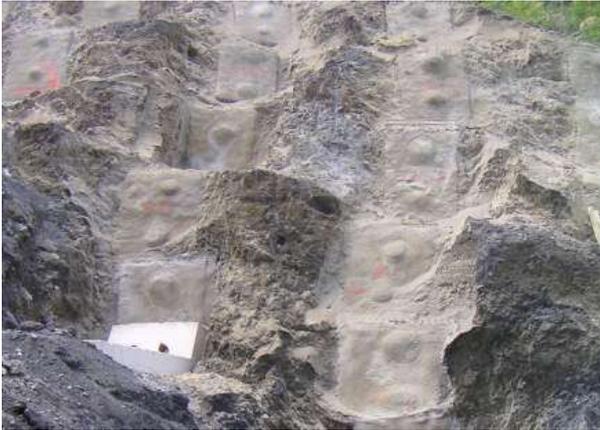
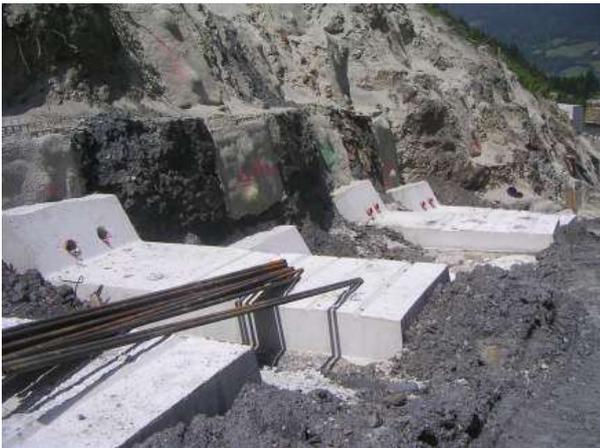
Figure 4 Measures to stabilize and drain slope cuttings at foundation level

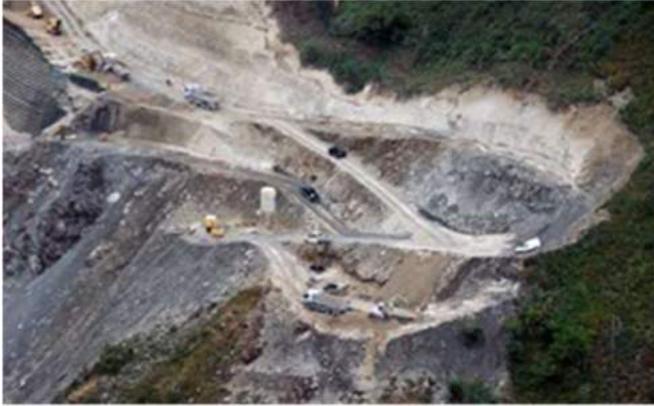
Figure 6 Haul roads

Most of the works were performed in extremely difficult, steep terrain. The haul roads had to be built with very tight widths, steep gradients and small curve radii. Every effort was therefore made to maximize efficiency in the complex process of transporting soil and materials.

The flexibility of the specified geogrid product (Fortrac®) played a key role in simplifying transportation. The geogrids were cut to size, folded and palletized at a central location on the basis of detailed placement plans. This allowed problem-free movement of the geogrids along the narrow haul roads to the work location.

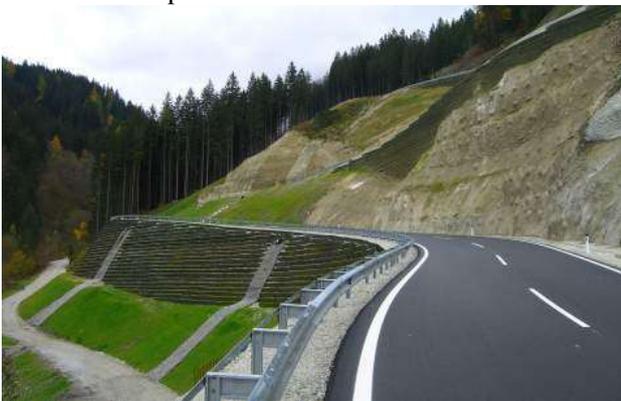
Figure 8 View of some of the described GRS slopes

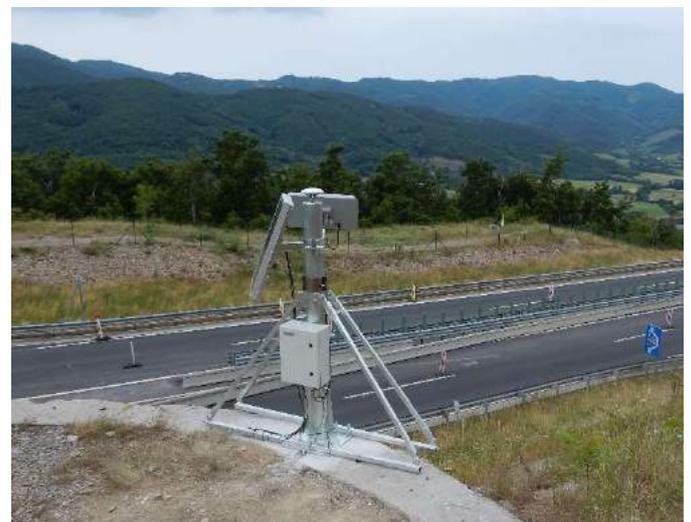
Figure 1 Standalone GIMS unit (Photo: E. Šegina).

The GIMS unit is a stand-alone monitoring unit based on the three surveying technologies: GNSS, SAR and IMU (Fig. 1).

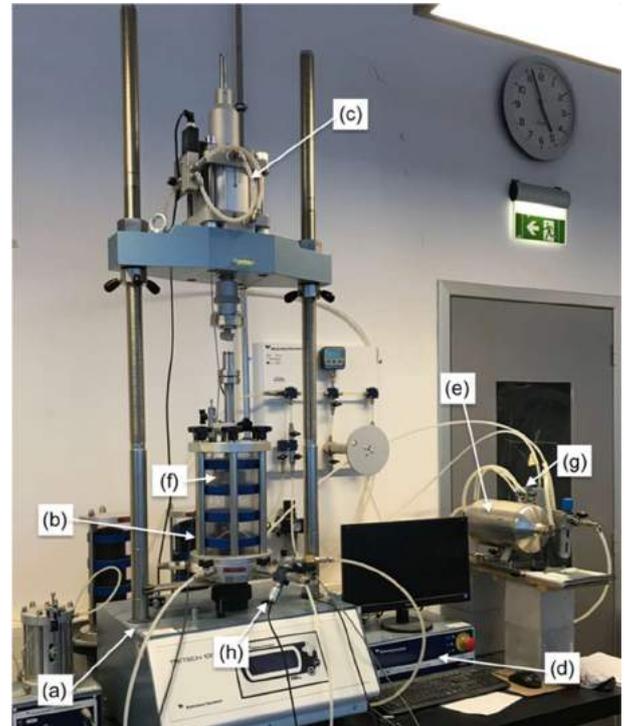
Figure 2 Dynatriax cyclic triaxial system

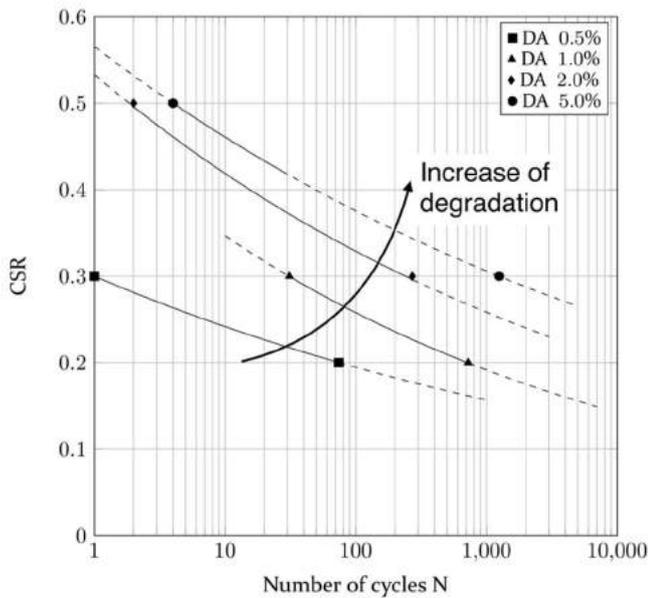
Figure 3 Variation of CSR with number of cycles with respect to double amplitude cyclic strain

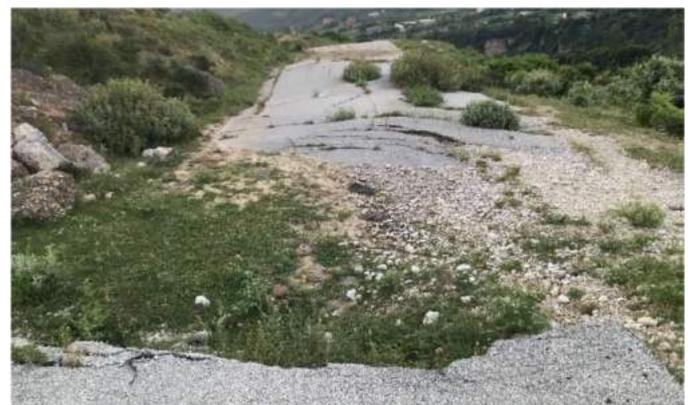
Figure 2 Landslide view, km 7+500[2]

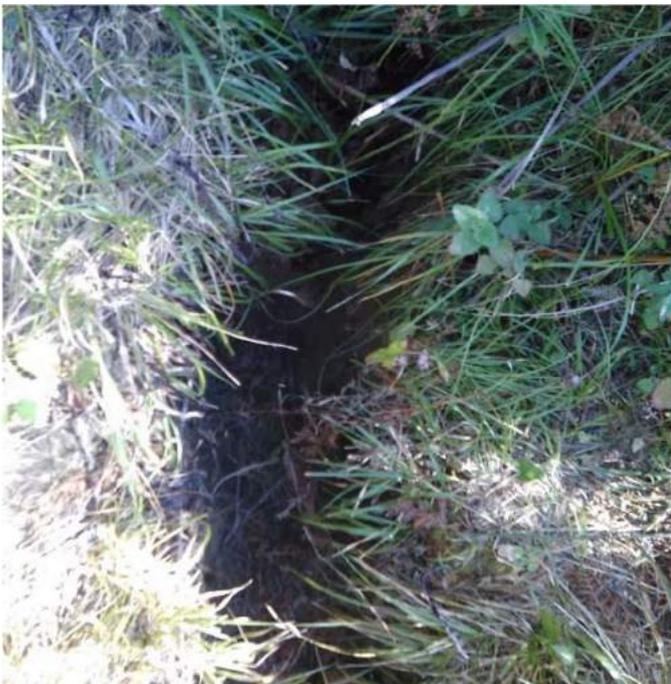
Figure 4 Open slope near km 7+800[2]

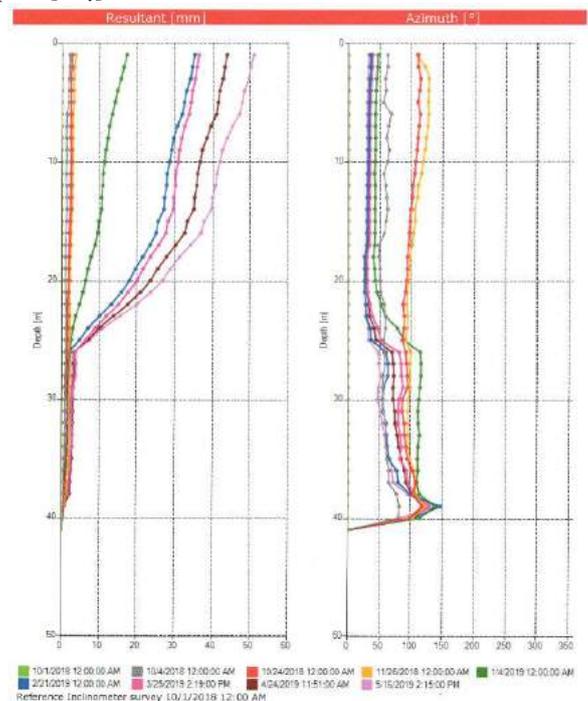
Figure 11 Inclinometer results at BH-3 from January 2018 up to May 2019[2]
