Proceedings of the 4th Regional Symposium on

LANDSLIDES

in the Adriatic - Balkan Region

23-25 October 2019, Sarajevo, Bosnia and Herzegovina

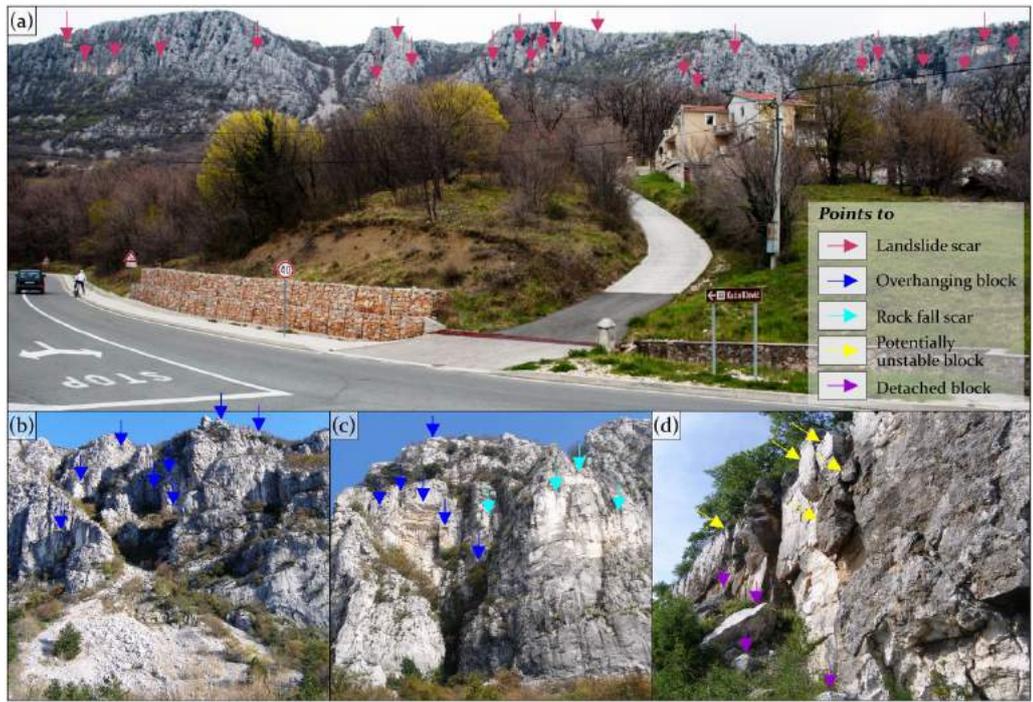
Figure 2 Rock falls and rock topples identified along carbonate cliffs in the Vinodol Valley: (a) scars of recent rock falls; (b, c) chutes with overhanging blocks, rock fall scars, and associated recent talus deposits; and (d) potentially unstable and detached blocks.

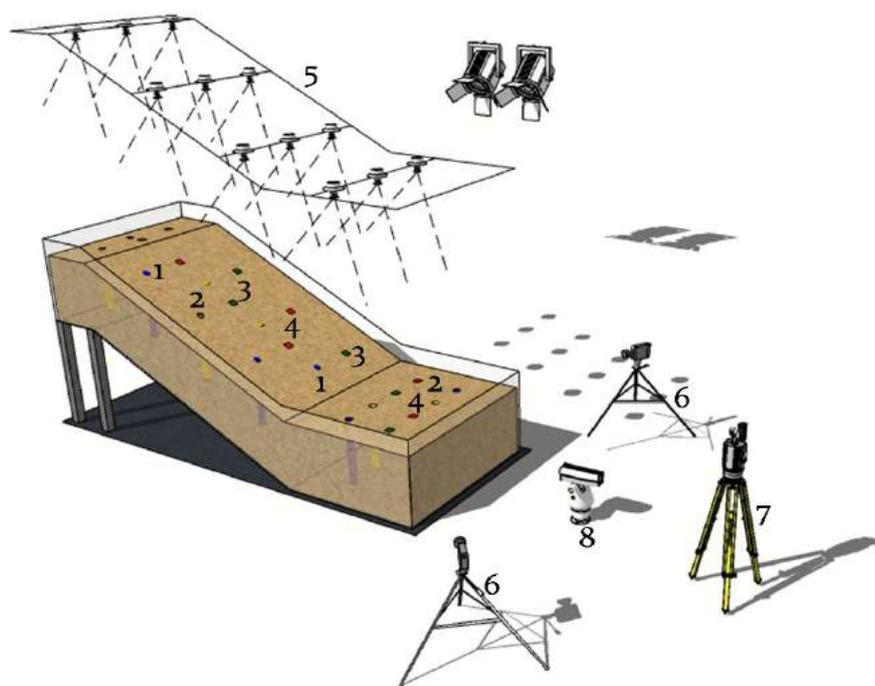
Figure 1 Physical model for static actions: 1-tensiometers, 2-pore pressure transducers, 3-strain gauges, 4-accelerometers, 5-rainfall simulator (sprinkler system), 6-high speed cameras, 7-terrestrial laser scanner, 8-infrared camera

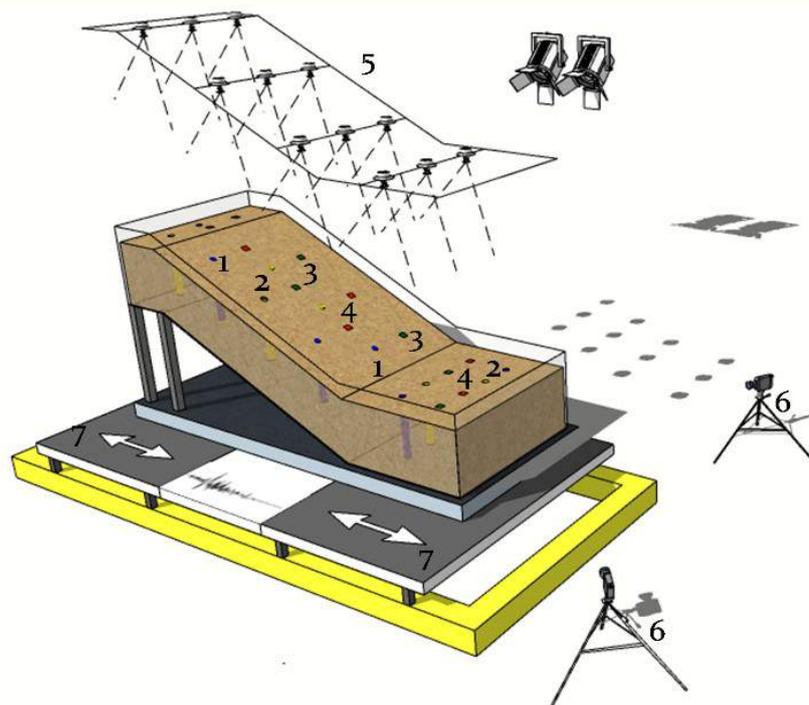
Figure 2 Physical model for seismic actions: 1-tensiometers, 2-pore pressure transducers, 3-strain gauges, 4-accelerometers, 5-rainfall simulator (sprinkler system), 6-high speed cameras, 7-biaxial shaking tables

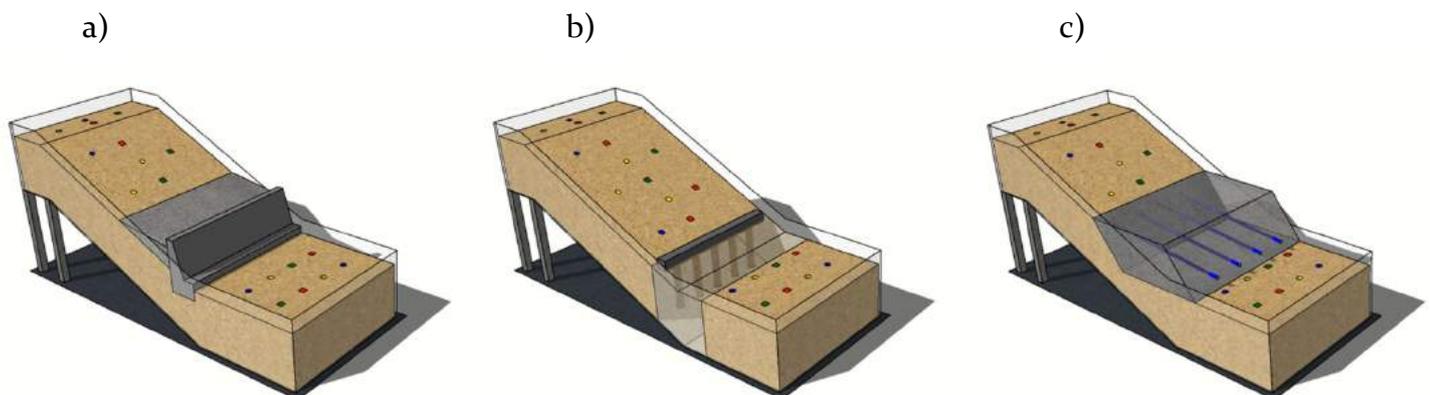
Figure 3 Physical model with different remediation constructions – a) retaining wall; b) pile wall; c) buttressing with drainage systems.

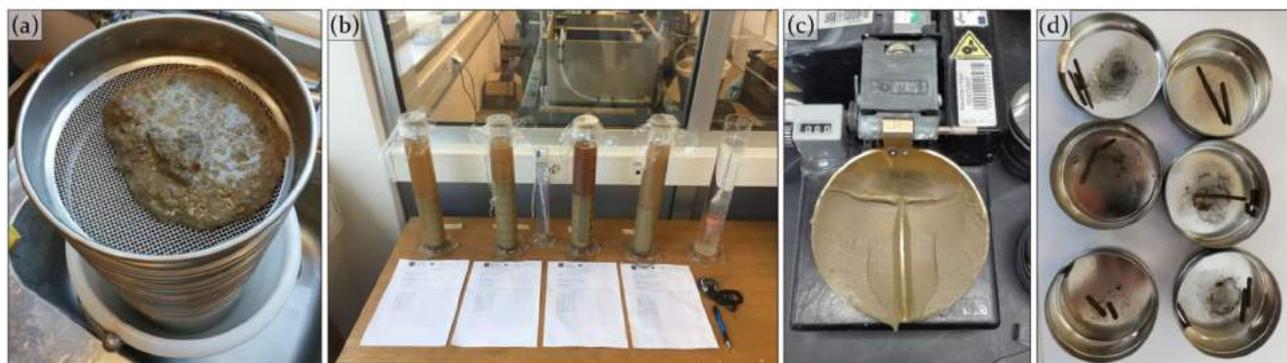
Figure 2 Soil samples during the laboratory testing methods: (a) the wet sample prepared for the wet sieve analysis; (b) the fine-grained soil sample components during the hydrometer analysis; (c) the sample prepared for the liquid-limit test; and (d) the samples after the plastic-limit test.

The particle-size analysis was performed by sieve analysis for the coarse-grained, and by hydrometer analysis for the fine-grained soil samples components. All soils were sieved by applying the wet sieving method (Fig. 2a). A series of sieves were in range from 20 mm and 0.063 mm. Preparation of samples started 24 hours prior the wet sieve analysis. Samples were initially soaked in a solution of water and sodium hexametaphosphate, and then shaken in the sieve shaker according to the used standard. Sieves were left to drain, and samples were dried in the dryer on $105 \text{ }^\circ\text{C}$ for 24 hours. The dried soil material masses retained on the sieves were weighted and recorded. The hydrometer analysis relates the terminal velocity of the grains in suspension, their density, and the density of the fluid (Holtz et al. 2011). Based on this test, the grain diameter can be calculated from the distance and the time of fall. The hydrometer also determines the density of the suspension, and this provides the calculation of the percentage of particles of a certain equivalent particle diameter at a given time. From the results of the hydrometer analysis, the percentage of clay fraction in whole tested sample was calculated for each sample.

Liquid-limit (LL) tests were performed using the Casagrande liquid-limit device (Fig. 2c). Each sample was prepared 24 hours prior the test (BS 13377-2 2010). After performing the liquid-limit tests, plastic-limit (PL) tests were performed (Fig. 2d), and the plasticity index (PI) was calculated for each sample. Finally, the activity of clays was determined for each sample, as the ratio of the plasticity index (PI) and the percentage of clay particle size (Skempton 1953), providing a good correlation between the activity and the type of clay minerals (Holtz et al. 2011).

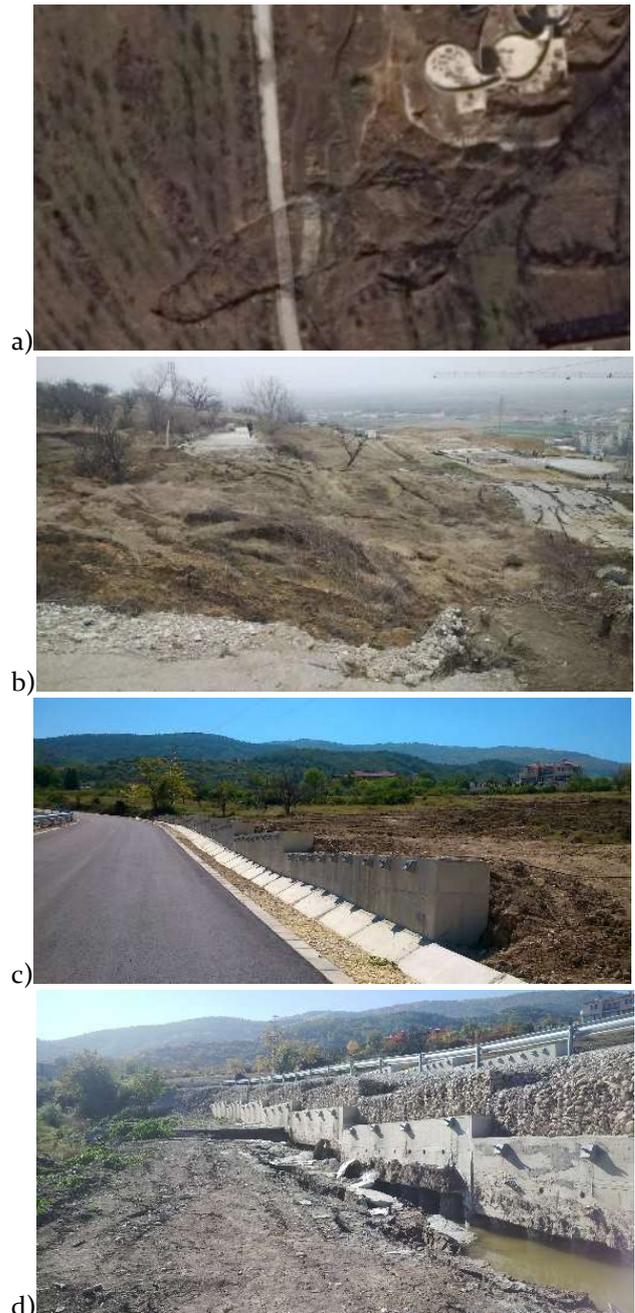
Photo 1 a) Satellite image of the landslide. b) Displacement of the road. c) Local stabilization of the road. d) Slide after the execution of the primary stabilization.

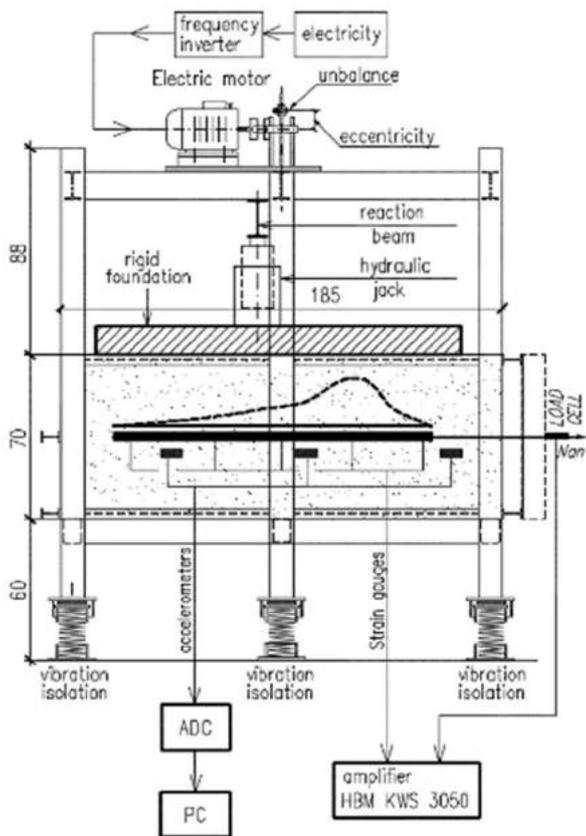
Figure 6 Model for testing anchors

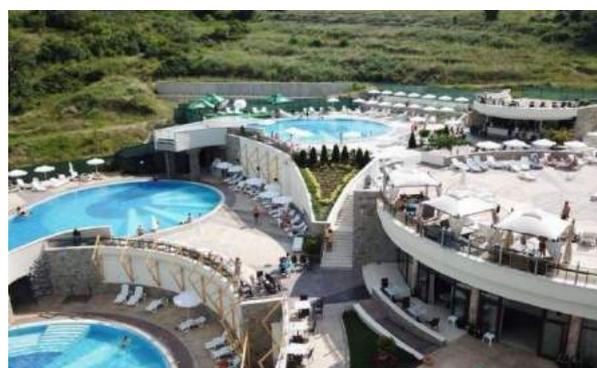
Photo 5 The landslide, the retaining wall and the aquapark

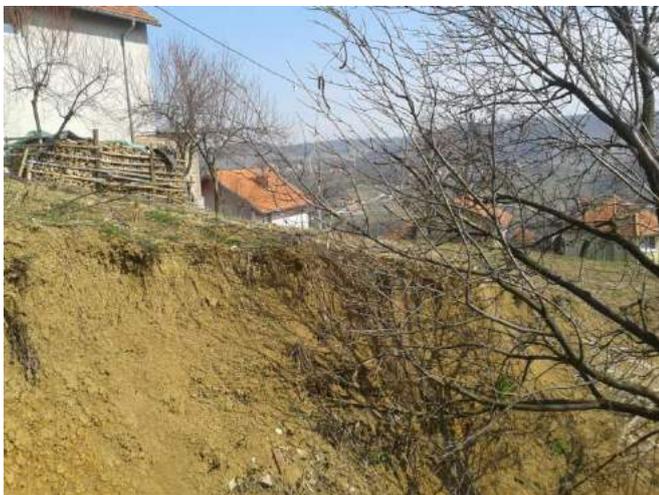
Figure 3 The landslide scar

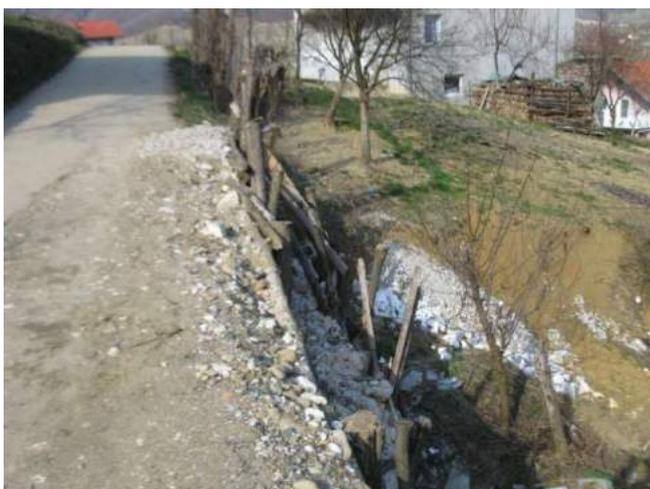
Figure 4 Damaged local road

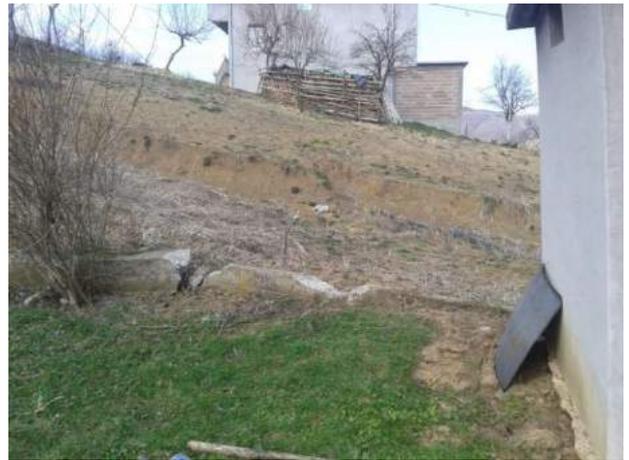
Figure 5 Dumped the retaining wall next to the house

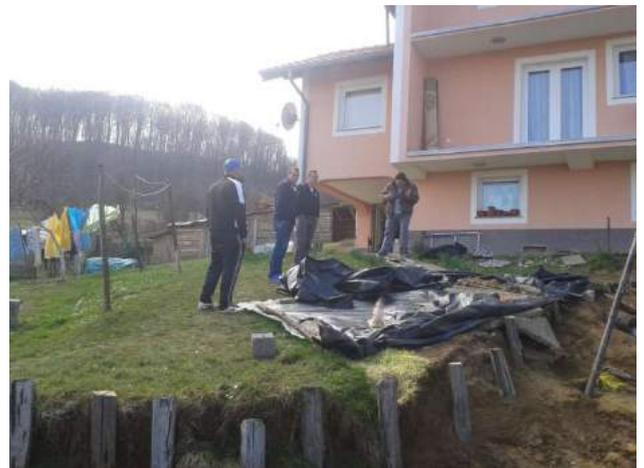
Figure 6 Wooden piles

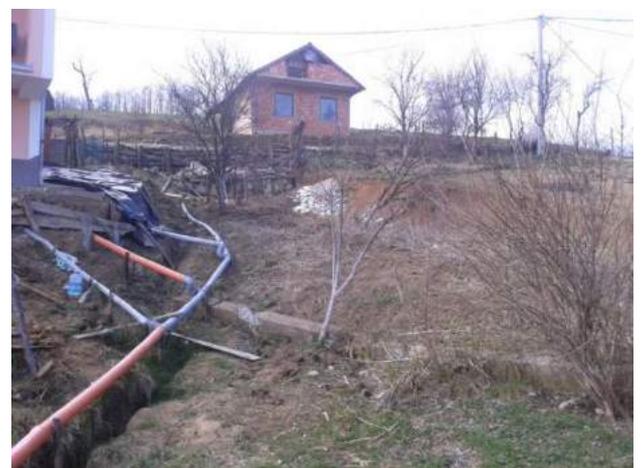
Figure 7 New plastic pipes instead of crumpled

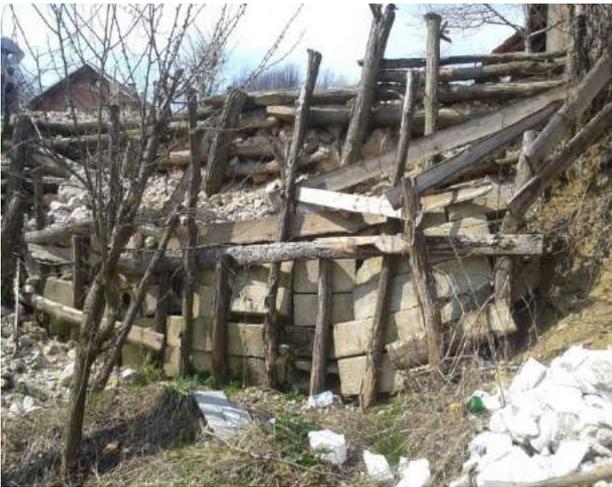
Figure 8 Temporary road repair

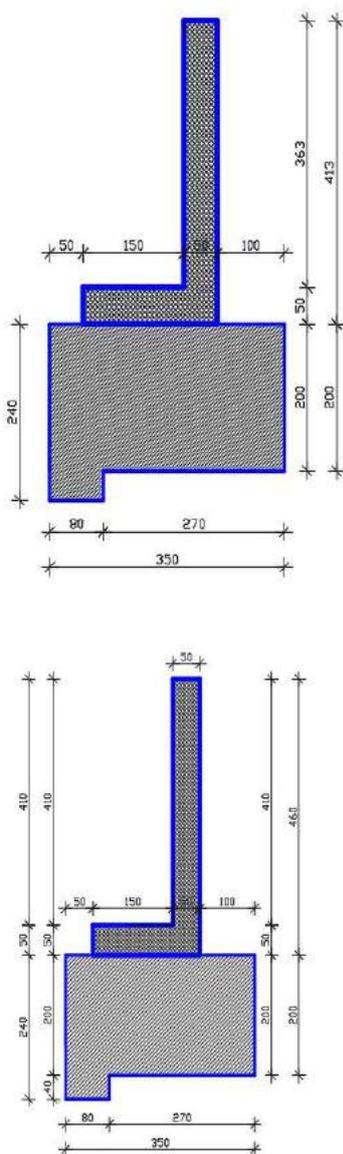
Figure 12 Retaining wall on counterforts

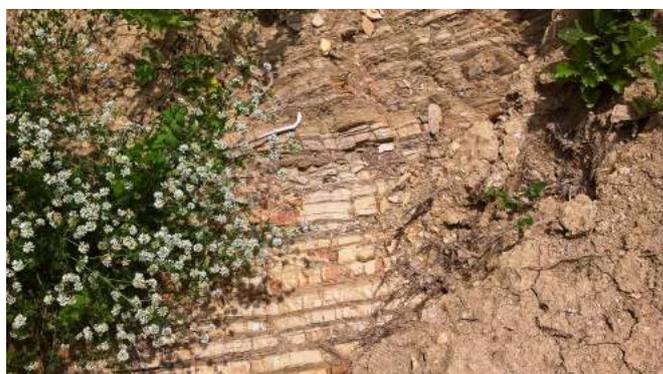
Figure 1 Marls and sandstones in alternation

sediments (M₃₁) - represented by ceratites limestones, marl clays, marls, and sandstones less frequently conglomerates. There is the frequent alteration of marls and sandstones in the field (Fig.1.) The orientation of the sediments is north-northeast, which is favorable from the aspect of stability because they are opposite of the slope inclination. The measured elements of dip and strike of the layer are Eds = 10/60 and Eds = 20/50. At this location during exploratory drilling, groundwater levels were measured and monitored in exploration boreholes.

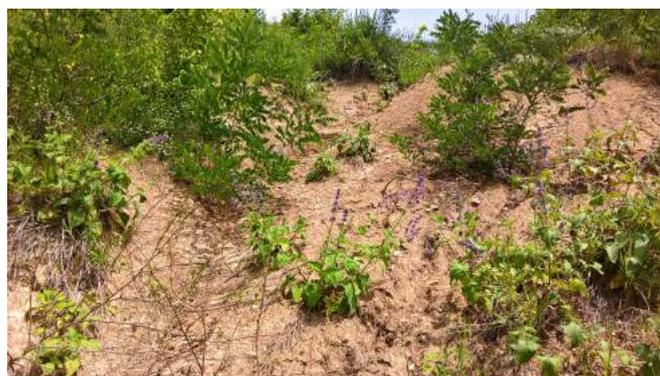
Figure 2 Sediment erosion on the slope

The landslide appeared on an eroded slope (Fig. 2.) where the rock mass is intensively degraded, which significantly interferes with and changes the composition, condition, and properties of the substrate present. Based on the registered large number of wells, it can be said that the slope is heavily saturated with water. In terms of stability (a division of slopes by degree of stability), this is an unstable slope where can expect the appearance of debris, rockfalls, and massive landslides. The hillside with activated landslide covers an area of 8.2 ha. According to the shape of the sliding body, the

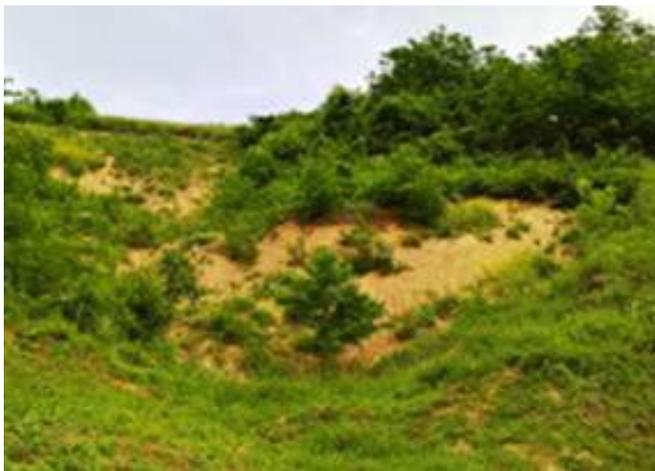
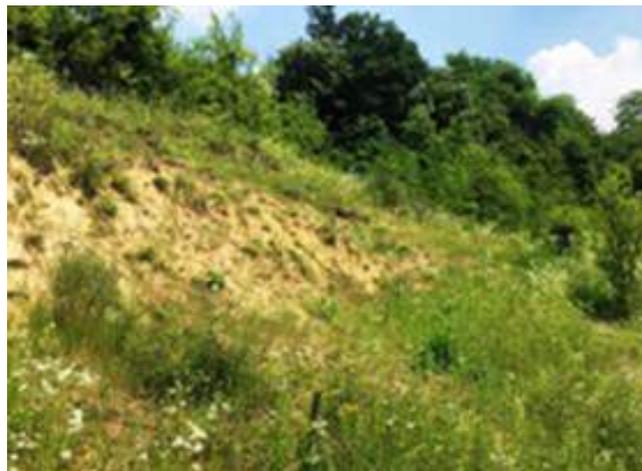
Figure 3 Landslide scar

abundant, unresolved drainage of surface water from the roads and heavy rainfall. Numerous landslide scars have been registered below the road at the top of the slope (Fig. 3.). In the upper part of the slope as a temporary remediation measure, a rock embankment has been used to stabilize road communication which on the other hand, serves as surface drainage (Fig. 4.).

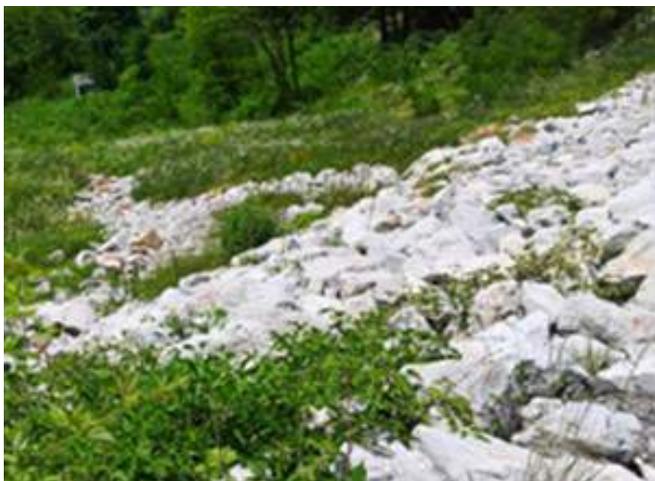
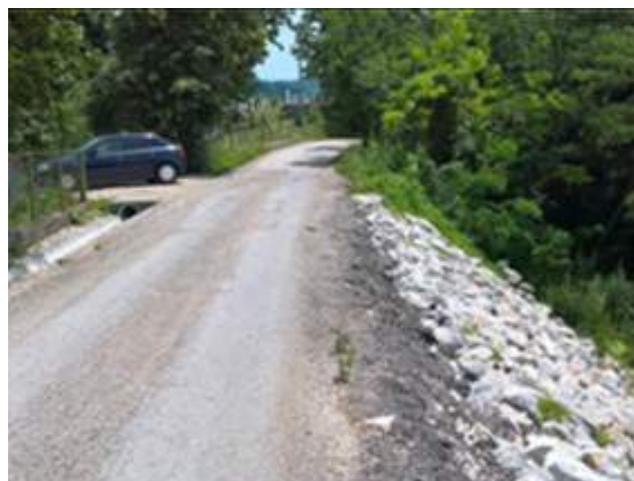
Figure 4 Rock embankment

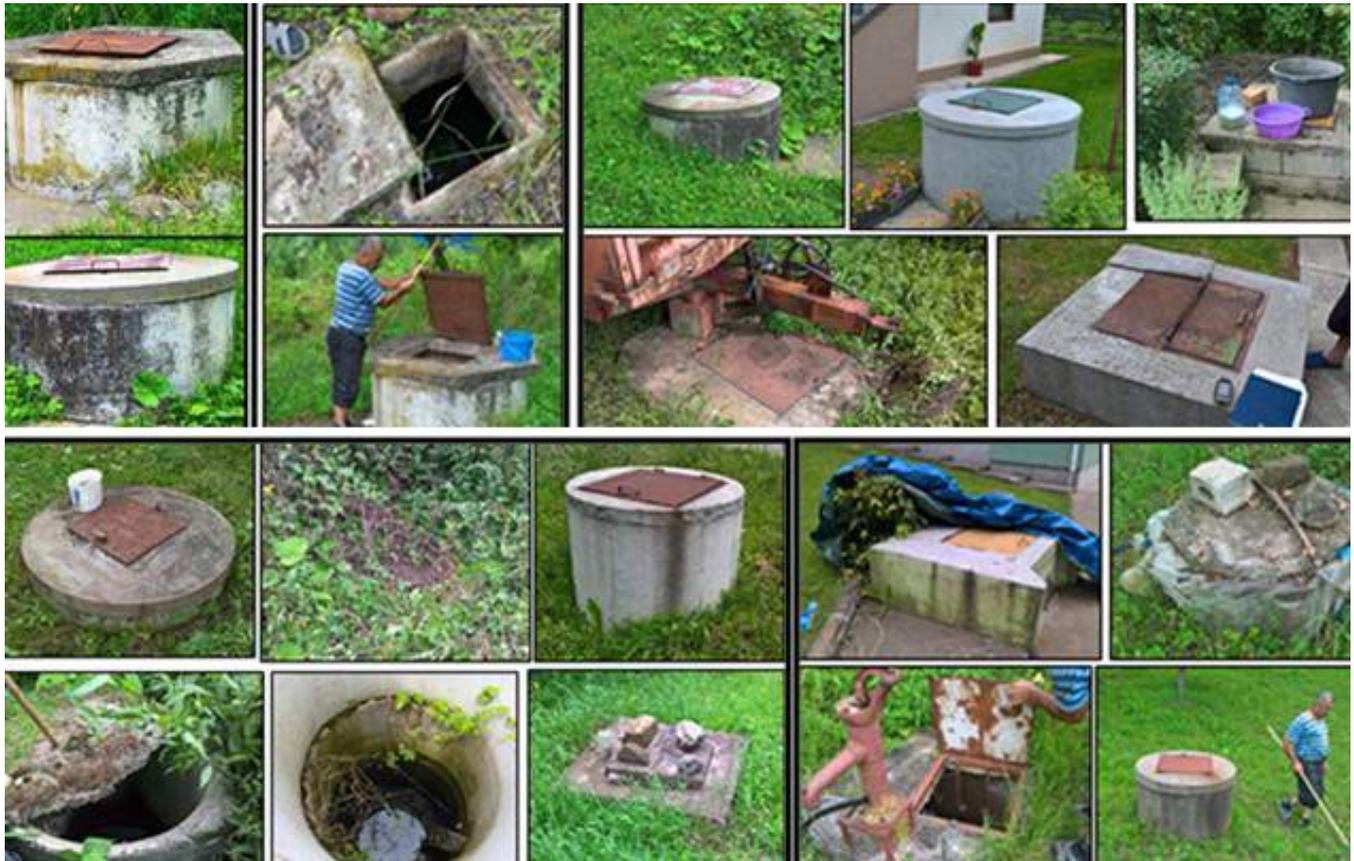
Figure 5 Registered dug wells on the landslide

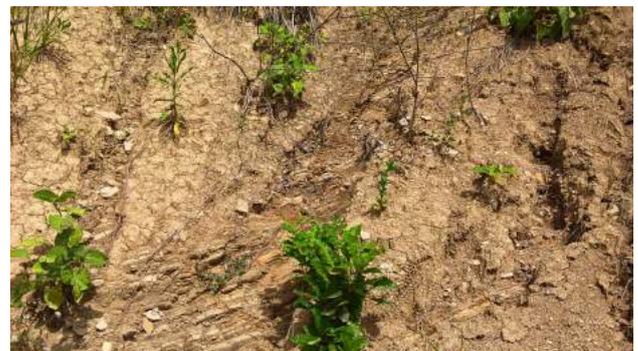
Figure 6 Layered marls and sandstones

Layered marls, sandstones and rare conglomerates that stratigraphically belong to the Upper Miocene sediments (M₃₁) present a geological substrate at the site

location (Fig. 6) Marls were drilled in all boreholes except borehole B-8. In this borehole, sandstones were drilled. Marls are also found in the landslide bodies where they shift with the sandstone.

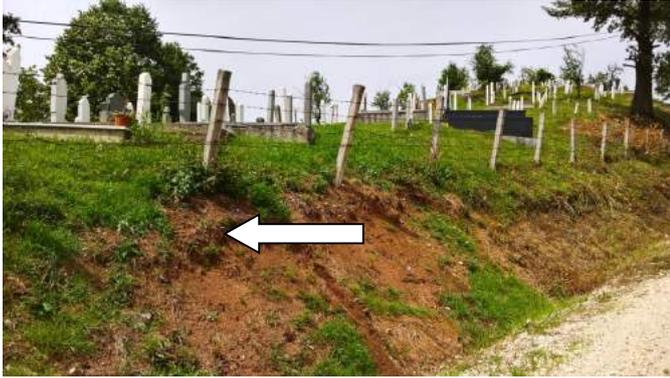
Figure 7 Conglomerates on the top of the ridge

Conglomerates were registered at the beginning of the ridge where the graveyard is located (Fig. 7).

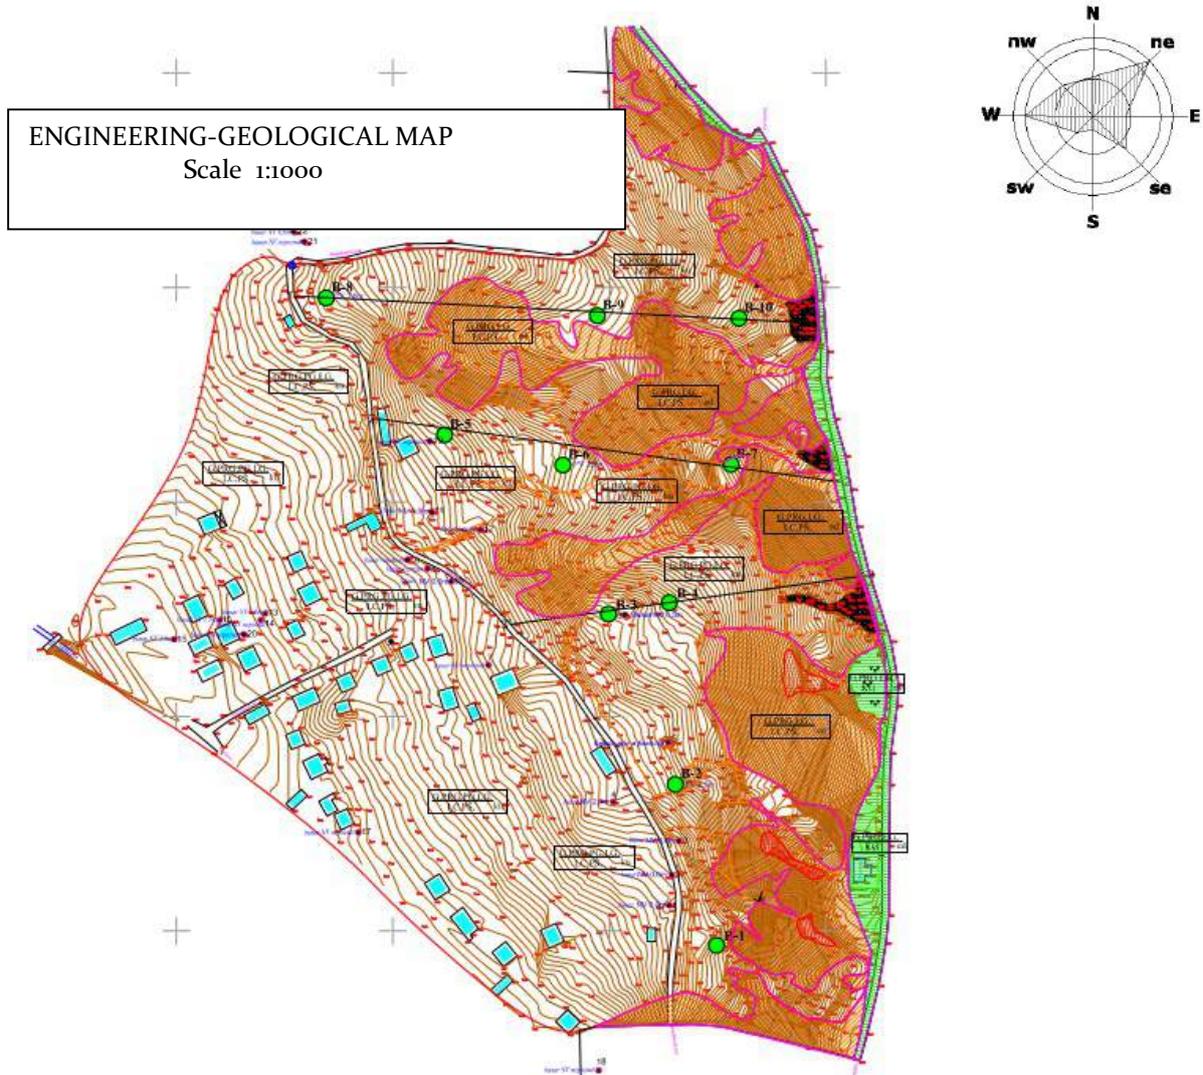
Figure 8 Engineering geological map of landslide Lisovići

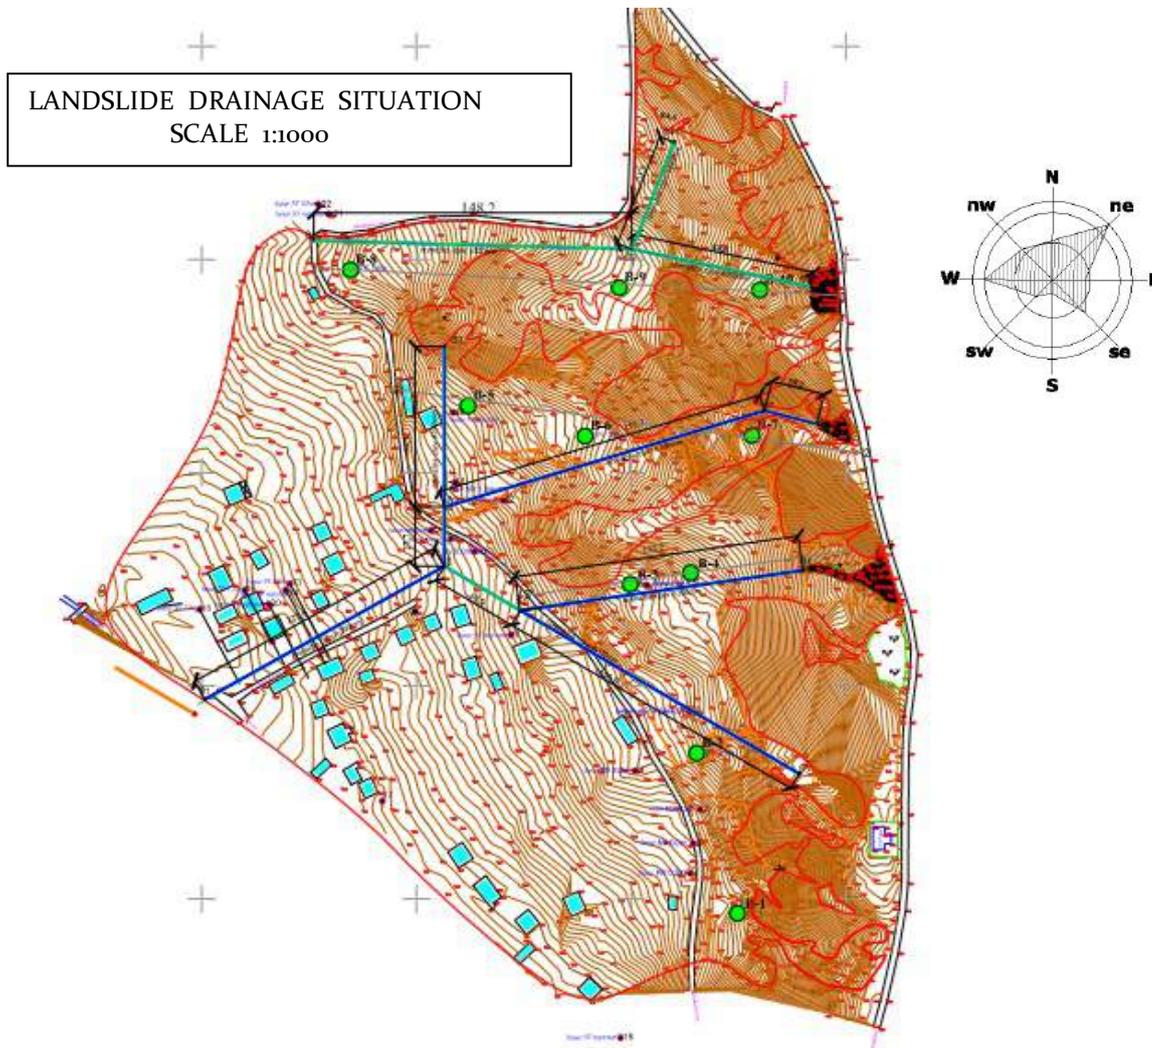
Figure 9 Remediation measures

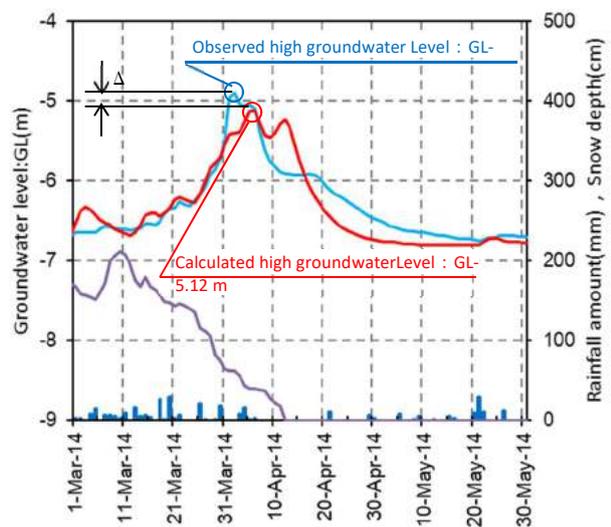
Figure 7 The observed groundwater level fluctuation and the calculated groundwater level fluctuation during snowmelt period in 2014

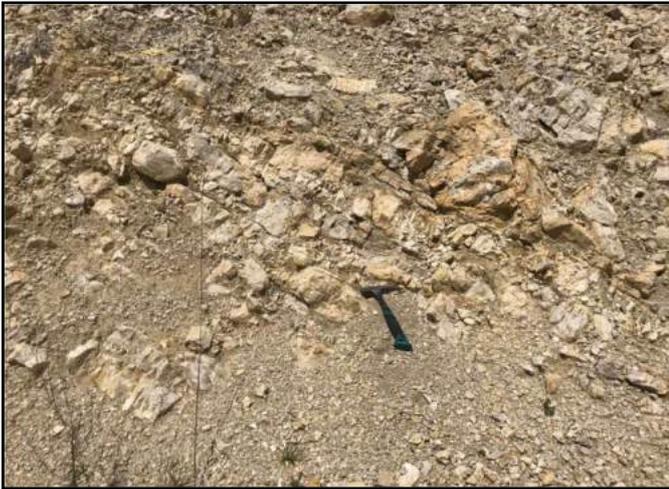
Figure 2 Triassic aged Candir formation (TRac) including claststone and siltstone.

Antalya nappes are divided into Tahtalıdag, Çataltepe, Alakırçay and Tekirova ophiolite nappes as stratigraphically and structurally in the study area (Senel et al. 1992; 1996). The following units were found in the landslide area: Candir (TRaç), Tekedağı (JKt), Kırkdirek (Kkm) and talus (Qym). The Candir formation (TRaç), named by Kalafatçioğlu (1973), shows a widespread at the lower elevations of the road route (Akca and Leventeli, 2019), (Figure 2).

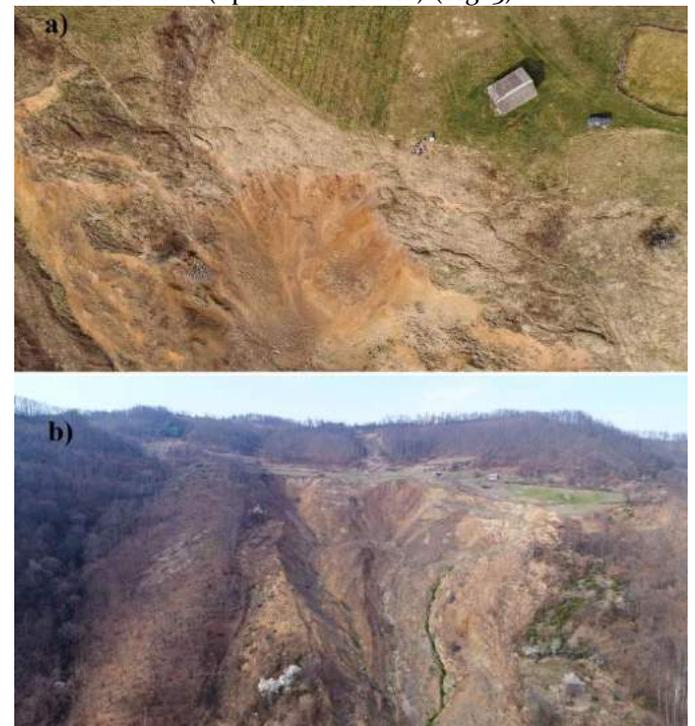
Figure 3 UAV images of a) source area b) transportation zone (April 2017)

Geological settings are very complex; initiation zone belongs to Jurassic ophiolites, while transportation and deposition area belongs to tectonic contact of Triassic limestones and magmatic rocks with Palaeozoic metamorphic rocks. Debris flow material is highly heterogeneous in lithological composition, as well as grain size distribution (up to m^3 boulders) (Fig. 3).

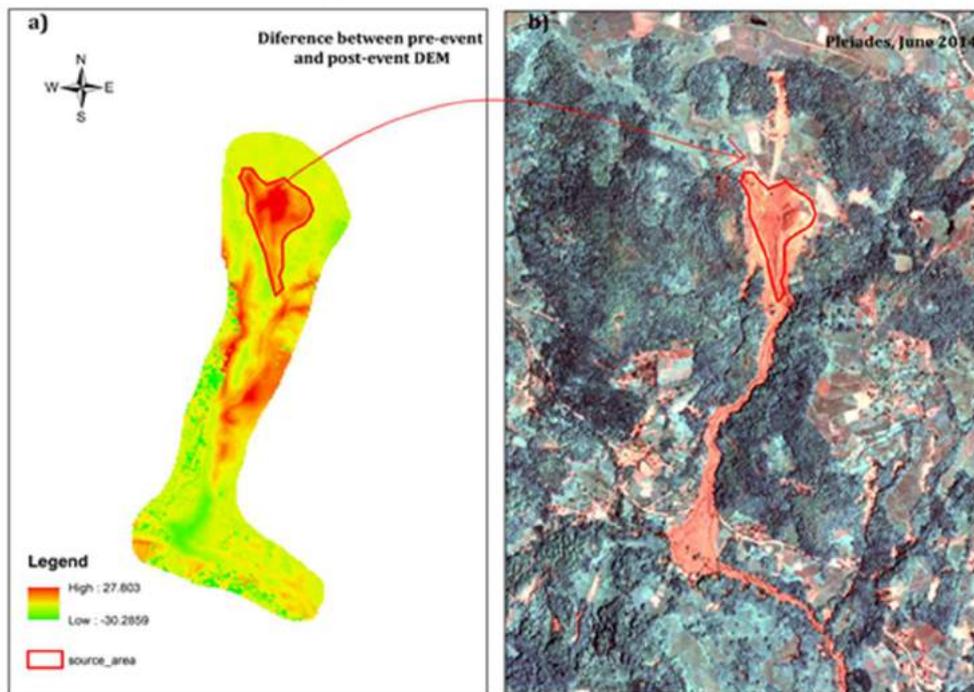
Figure 4 a) Calculation of difference in topography before and after the activation of the debris flow, b) Pleiades image after the event and position of defined release area

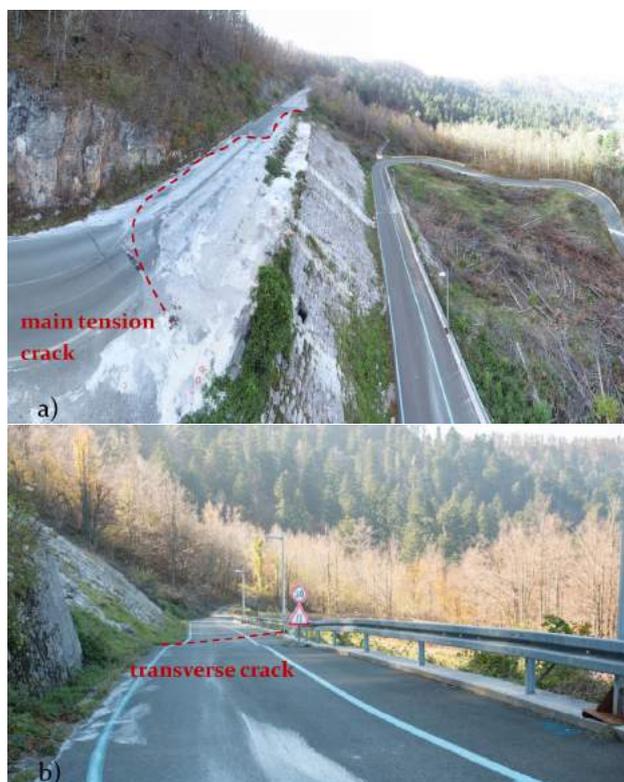
Figure 2 Evidences of the landslide movements: a) main tension crack on the state road D3, b) subsidence of the local road towards the Lokve Lake.

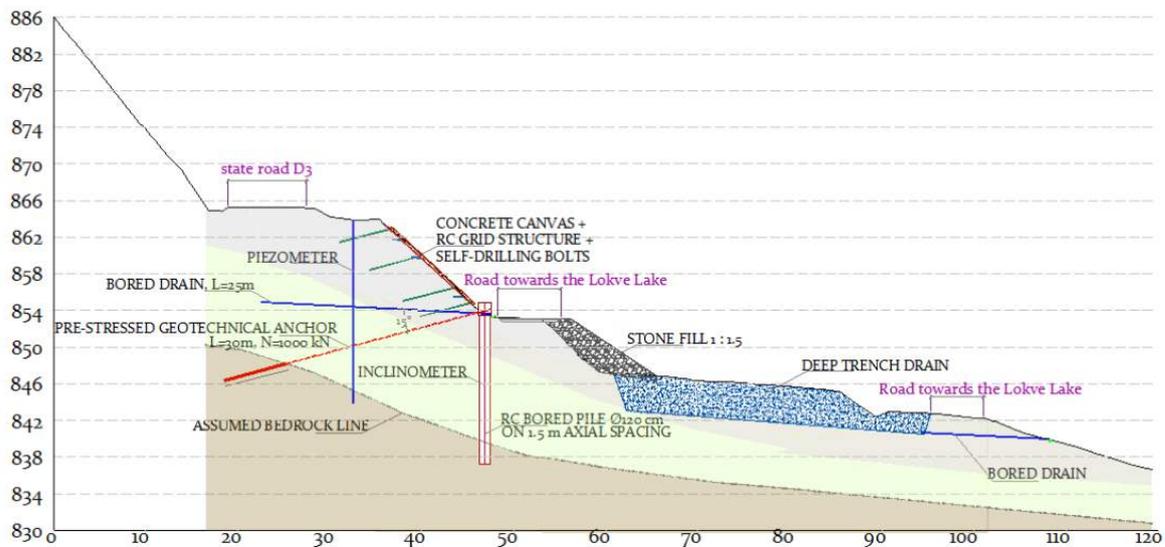
Figure 6 Representative cross section with remedial measures and monitoring equipment.

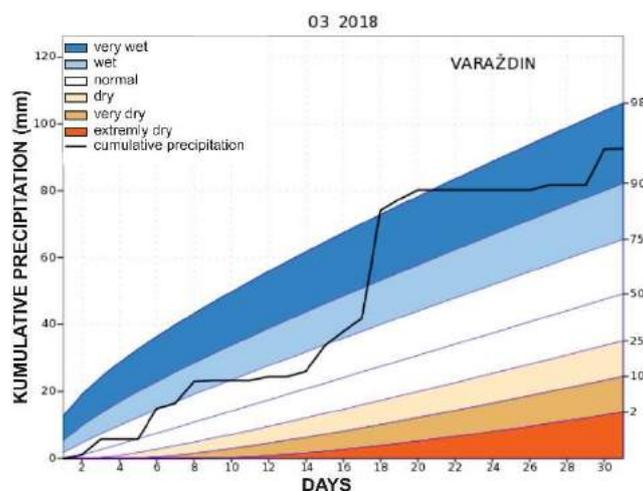
Figure 3 Cumulative daily precipitation (mm) on Varaždin meteorological station for March 2018 and the series of theoretical percentile curves (2., 10., 25., 50., 75., 90. i 98.) for period 1961 - 2000 (www.meteo.hr).

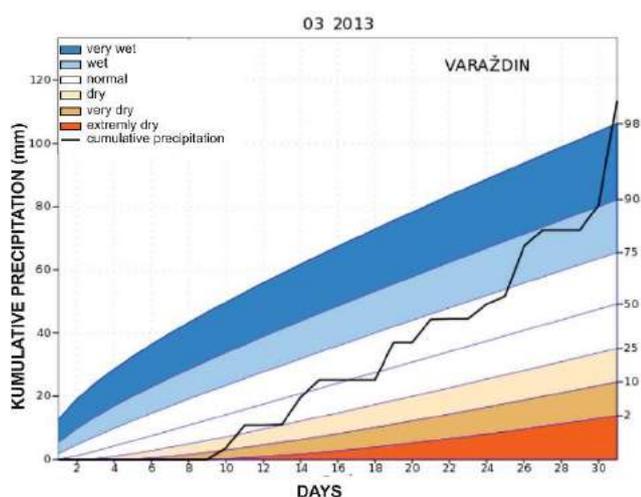
Figure 4 Cumulative daily precipitation (mm) on Varaždin meteorological station for March 2013 and the series of theoretical percentile curves (2., 10., 25., 50., 75., 90. i 98.) for period 1961 - 2000 (www.meteo.hr).

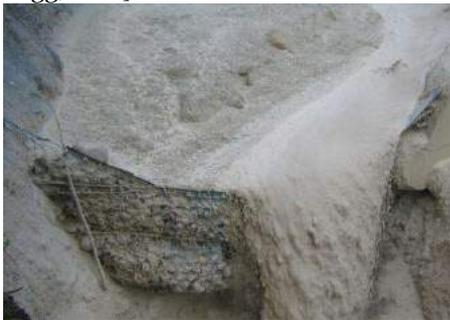
Figure 1 Flexible ring net barrier withstanding overflow in the Illgraben.

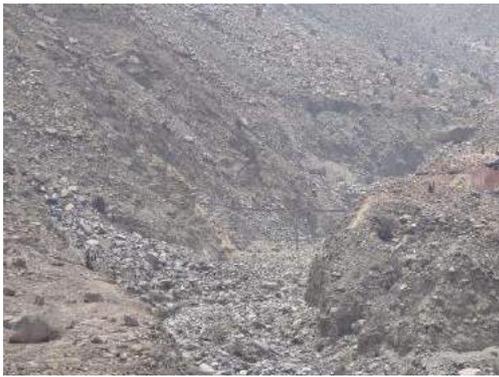
Figure 3 Steep, incised slopes overlooking Chosica's urban area and the unconsolidated material covering these slopes illustrate the debris flow potential.

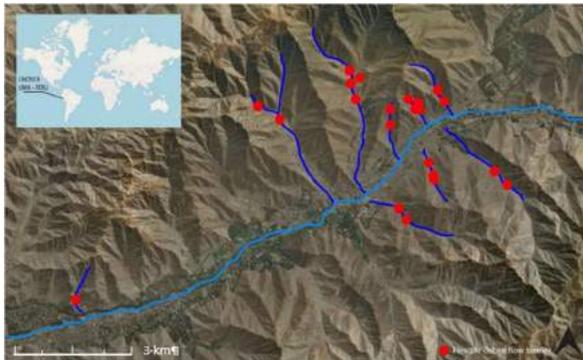
Figure 4 Case study overview in Cuenca del Rio Rimac Distrito de Lurigancho, Chosica, Peru with 22 installed flexible debris flow barriers (red dots).

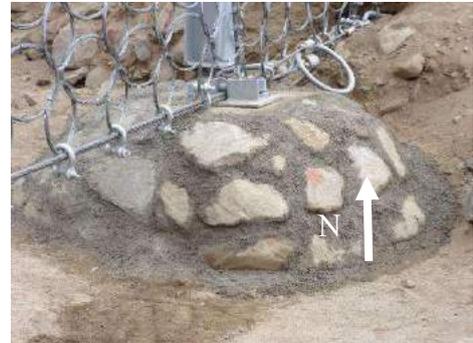
Figure 5 Scour protection around the posts for UX-barriers

designed abrasion protection for the top support rope (see Figures 5 and 6). Depending on the hydraulic conditions and the geometry of the different streams, UX or VX barriers were installed (Figure 7 and 8), as single barrier or in a multi-level combination. The largest barrier was set up in a multi-level setting (Figure 9).

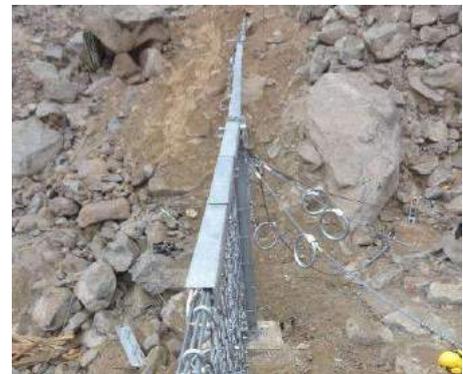
Figure 6 Abrasion protection for the top support rope

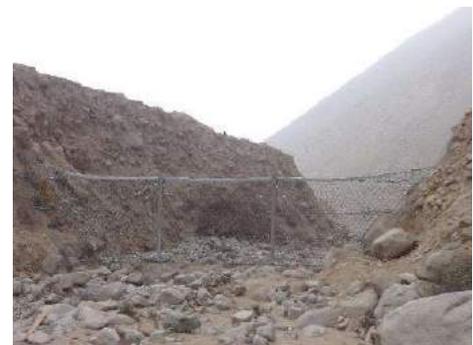
Figure 7 UX- barriers with two posts in the channel bed

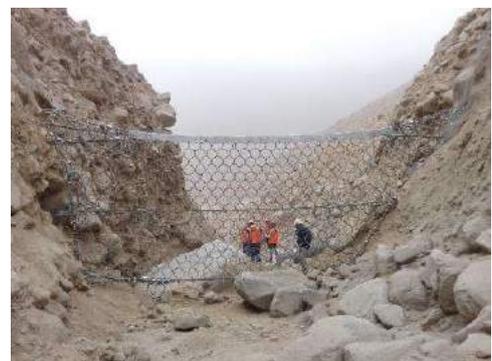
Figure 8 and VX barrier in a narrower channel

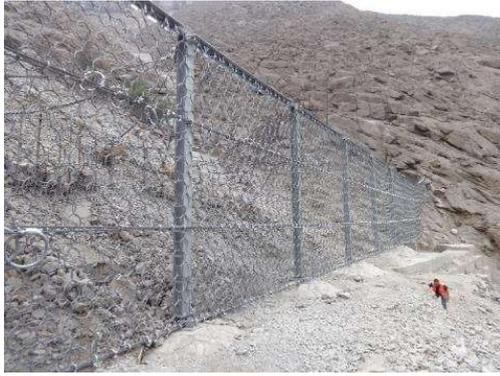
Figure 9 The highest barrier is the largest in South America.

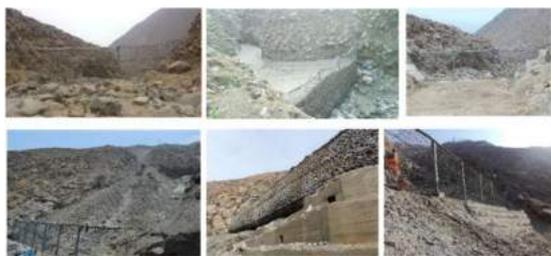
Figure 10 Before (2016) and after the debris flow event (2017) and subsequent maintenance (2018) for the stream San Pedregal (above) and Carrosio (below).

The first debris flows after installation happened a year later, in January 2017. Up to then, all barriers have retained debris in variable amounts. On average, their retention level has been around 4'600 m³. Subsequently, in February 2017, Peru was hit by great storms which caused even further, large, debris flow events. The flexible debris flow barriers kept fulfilling their function of retaining debris. The multi-level system was efficient since the barriers further downstream were not completely filled and still offer good retention capacity, for potential following debris flows. During the debris flow events post supports and cable supports got partially eroded. Hence, maintenance work on these elements was done. Eroded parts were rebuilt with new foundations, brakes and cables were replaced. Further, the barriers need emptying when the material is dry and stable. It can be cleaned with an excavator from behind or in certain conditions, when all safety requirements are met, from the front. Figure 10 illustrates the overall process for the barriers, from installation to filling to maintenance, ready for the next debris flow events.

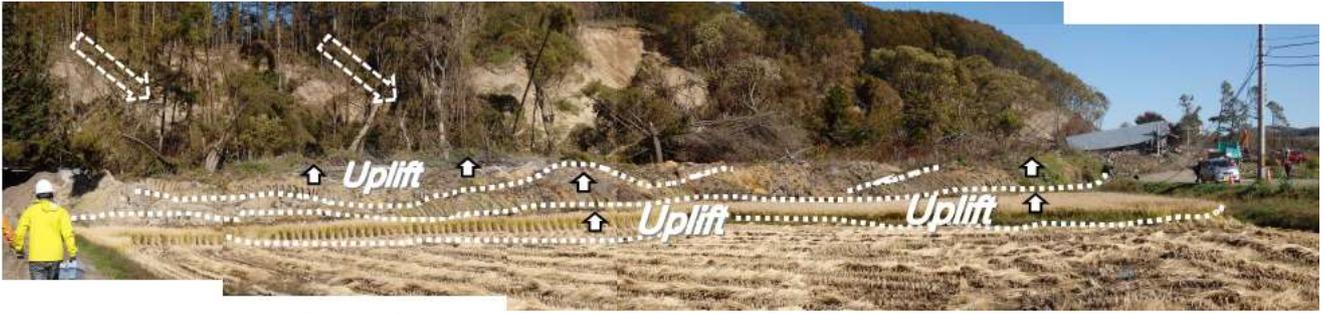
Figure 2 Squeezing-out phenomenon at Yoshino, Atsuma, Hokkaido

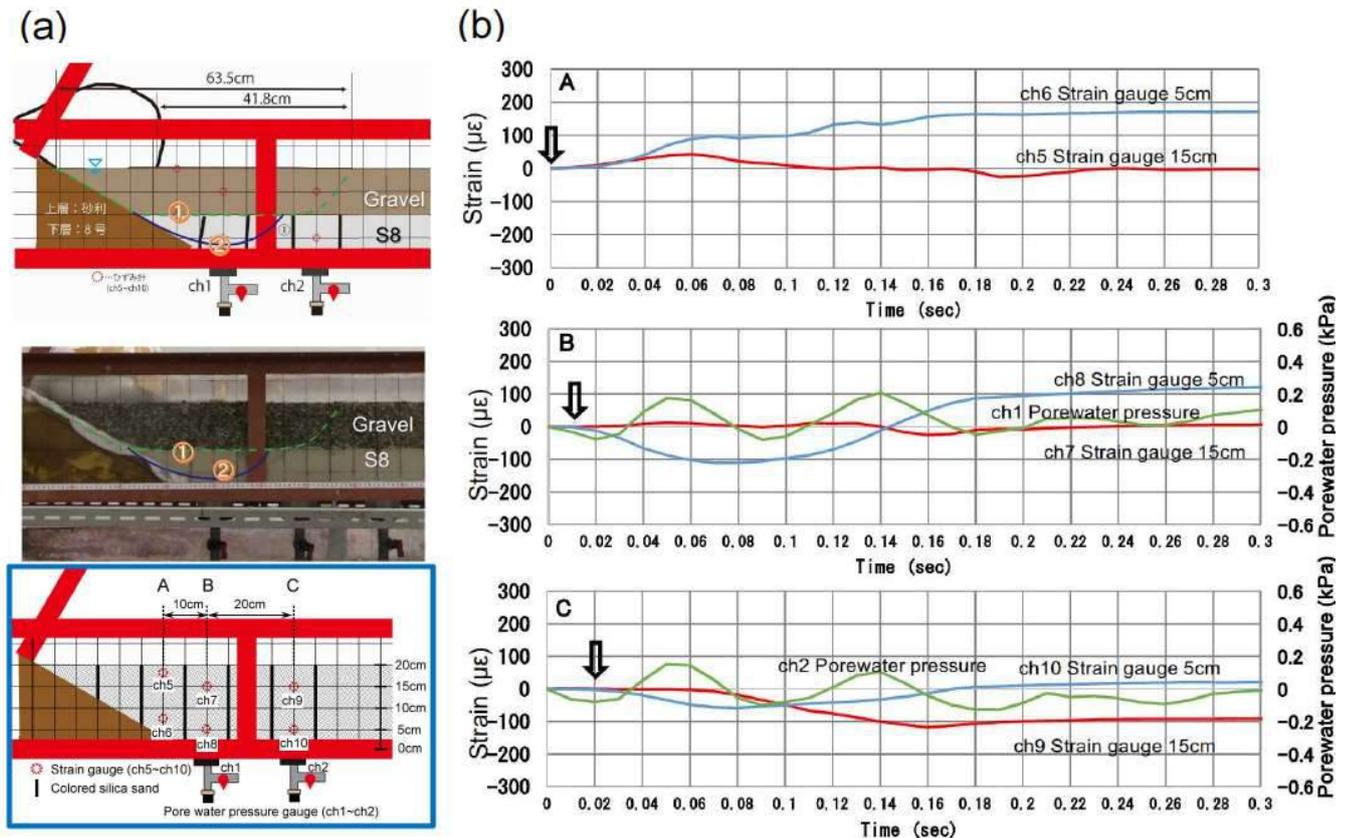
Figure 4 Result of Test No. 2-2 ((a): Photo and sketch; (b) Time serie change between starin and pore water pressure)

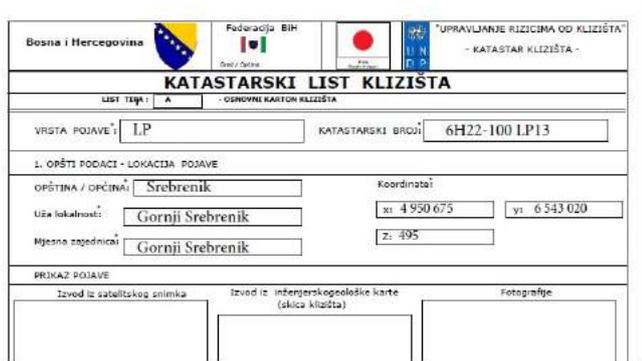
Figure 2 The part of a cadastre sheet

Landslides in the territory of Srebrenik Municipality are registered with cadastral records. All important data for a landslide are entered in the cadastral sheet (Figure 2). Landslide records are based on the occurrence of landslides after extreme rainfall since May 2014. So far, 350 landslides have been registered. The total landslide area is approximately 18 ha. The sliding surface is usually shallow and up to 5.0 meters depth.
