Proceedings of the 4th Regional Symposium on

LANDSLIDES

in the Adriatic - Balkan Region

23-25 October 2019, Sarajevo, Bosnia and Herzegovina

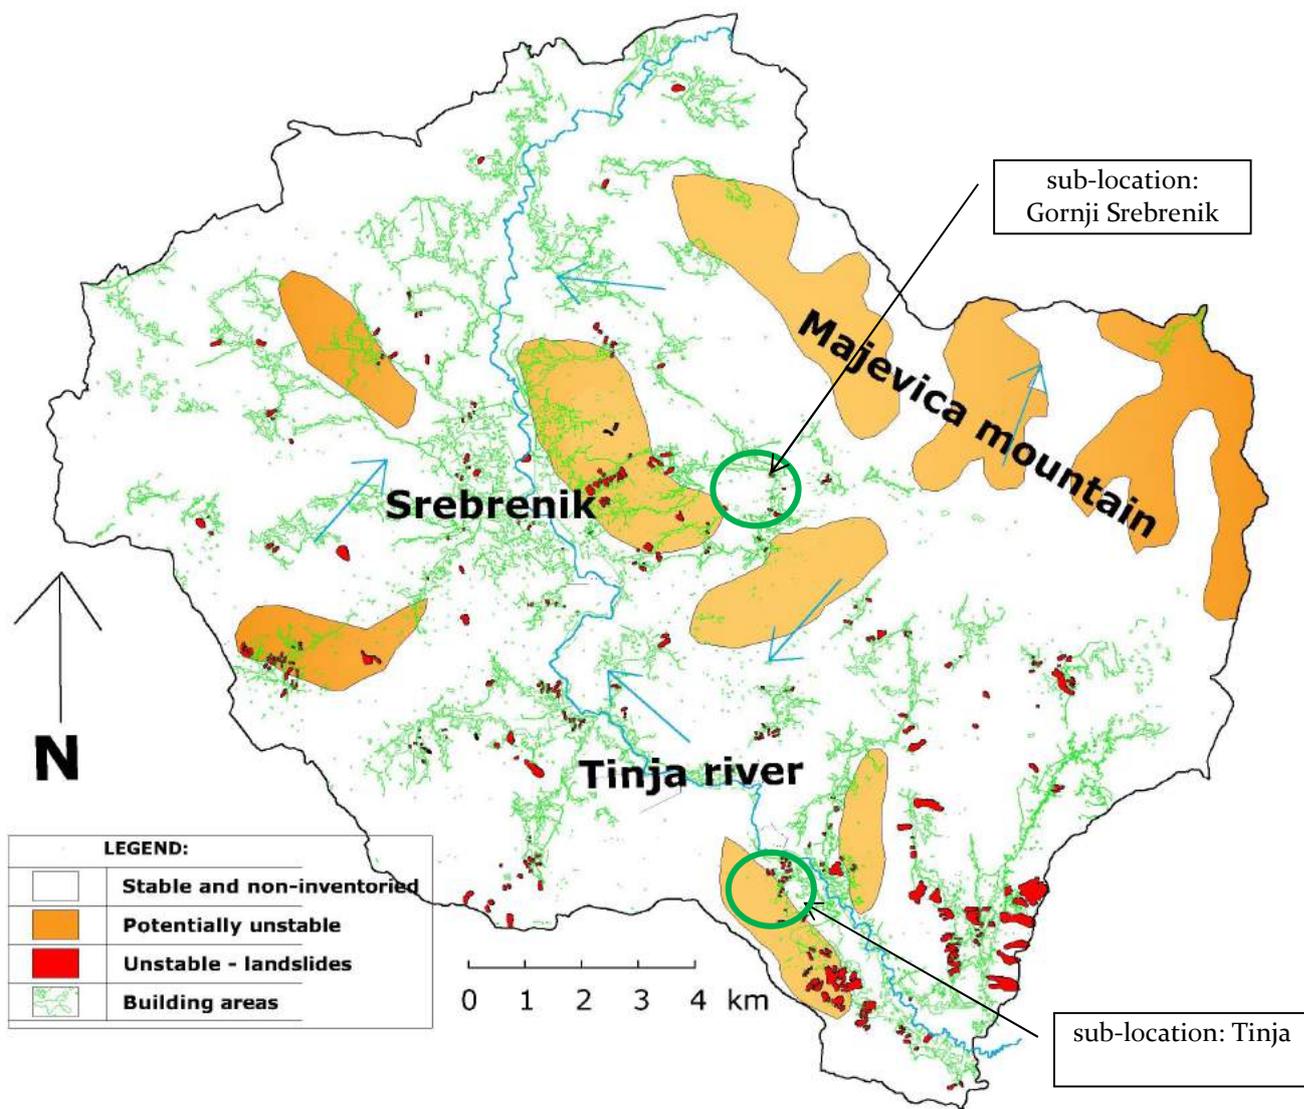
Figure 3 Stability map of Srebrenik municipality

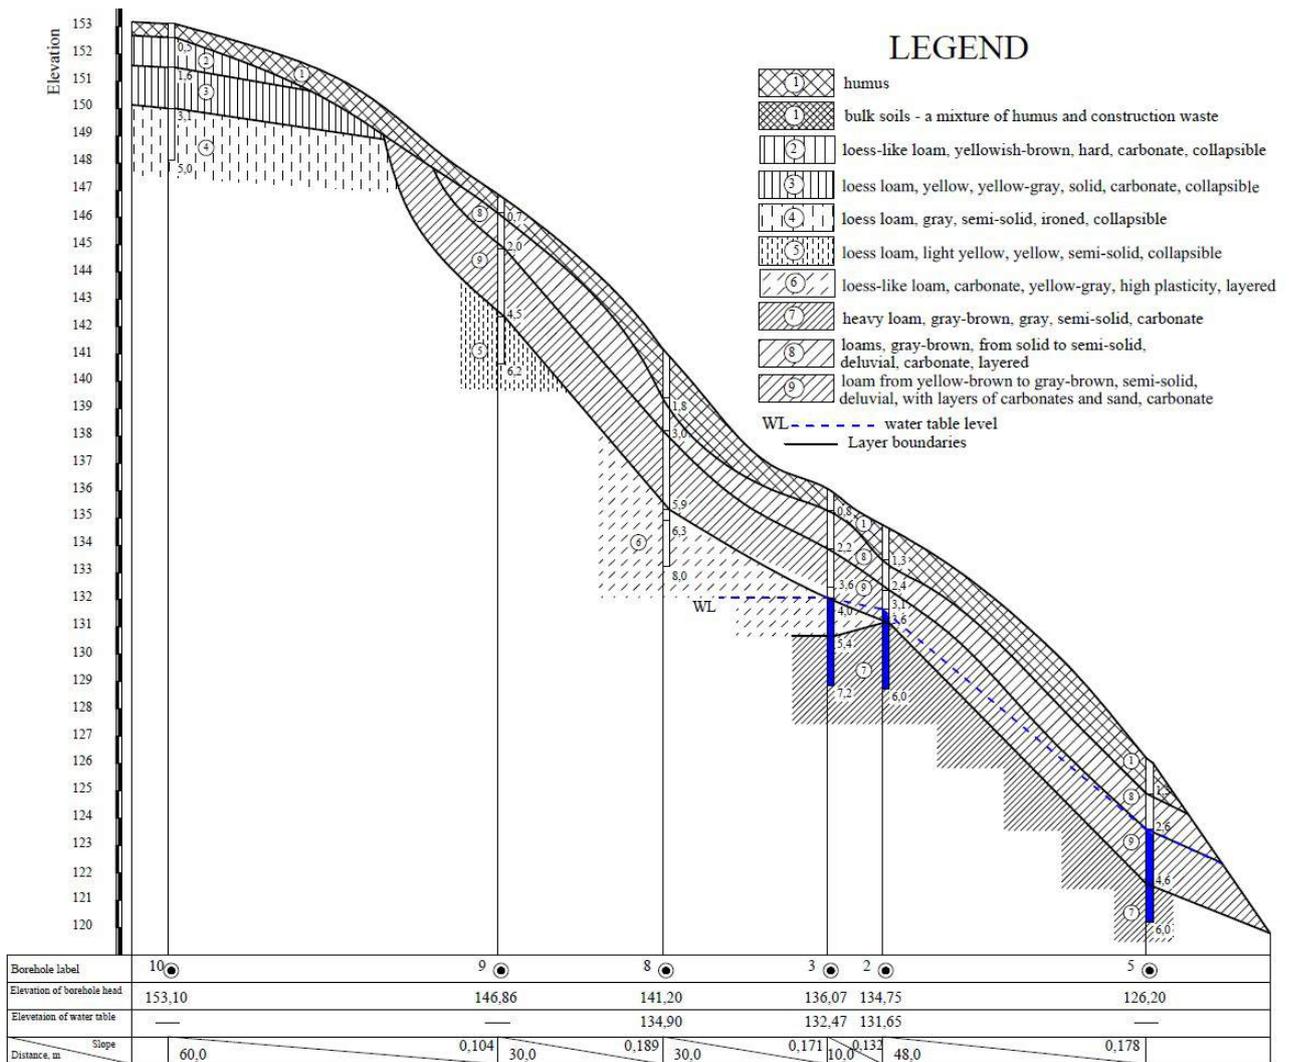
Figure 4 Engineering geological profile 1-1

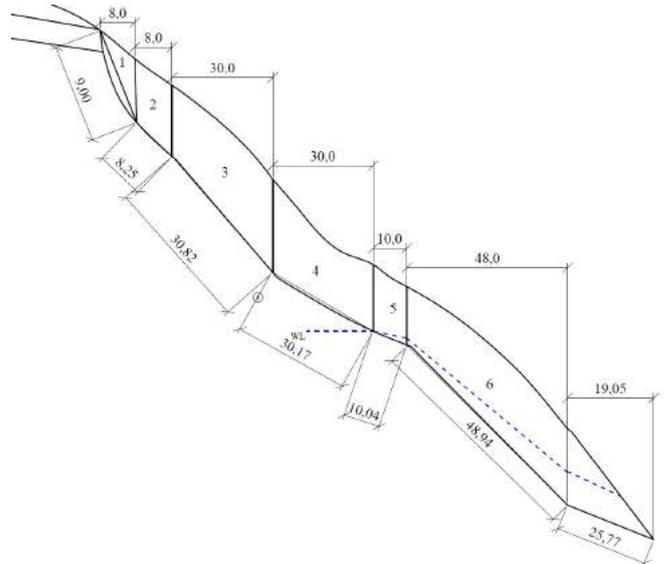
Figure 6 Distribution of the wedges in studied case

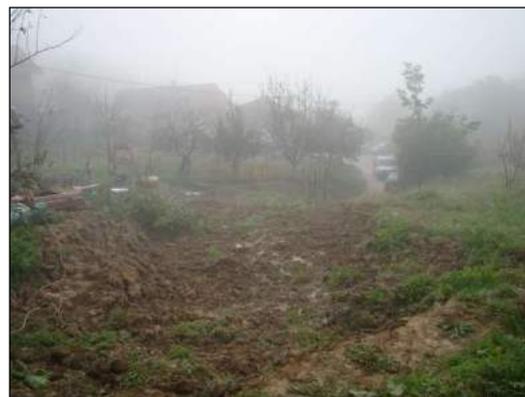
Figure 1 Landslide photo, a sliding mass that has been gravitationally moved along the road.

Visiting the subject site, a landslide was observed above the local asphalt road, shown in Fig. 1. Heavy rainfall caused the surface of the slope to defoliate, constant gravitational displacement of the material led to secondary shelling of the terrain with marked deformation of the terrain. The sliding process was even faster due to unfavorable slope of the terrain, which is just above the road. Sliding material covered the entire profile of the road and prevented traffic.

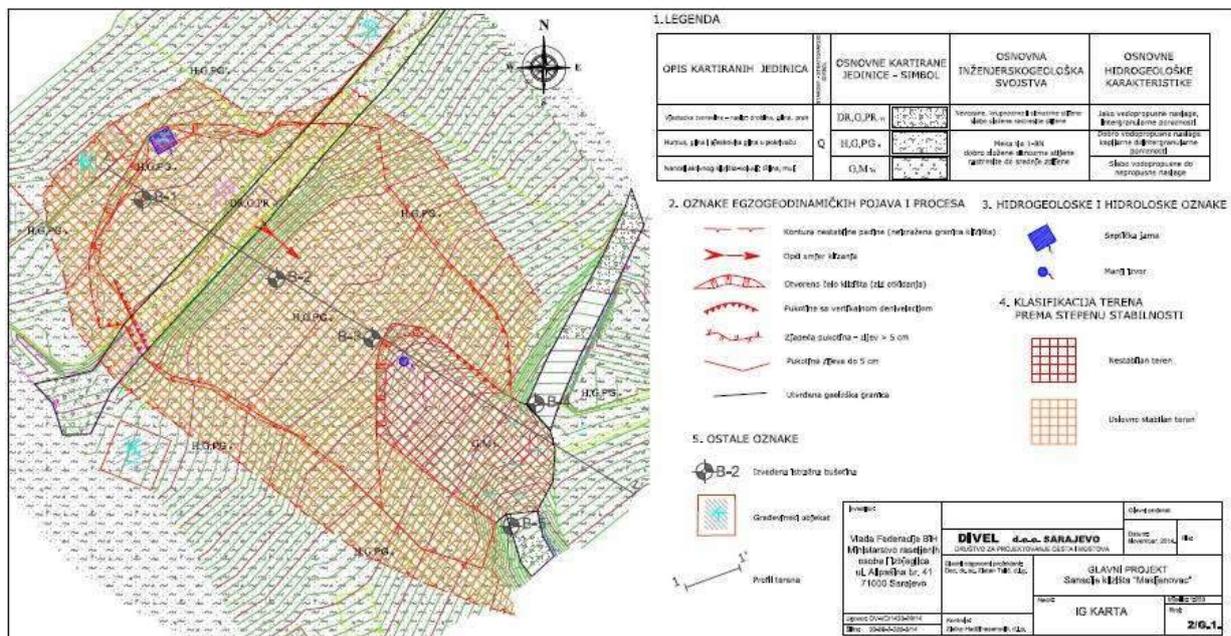
Figure 4 Engineering geological map (Retrieved from: Elaborate, 2014)

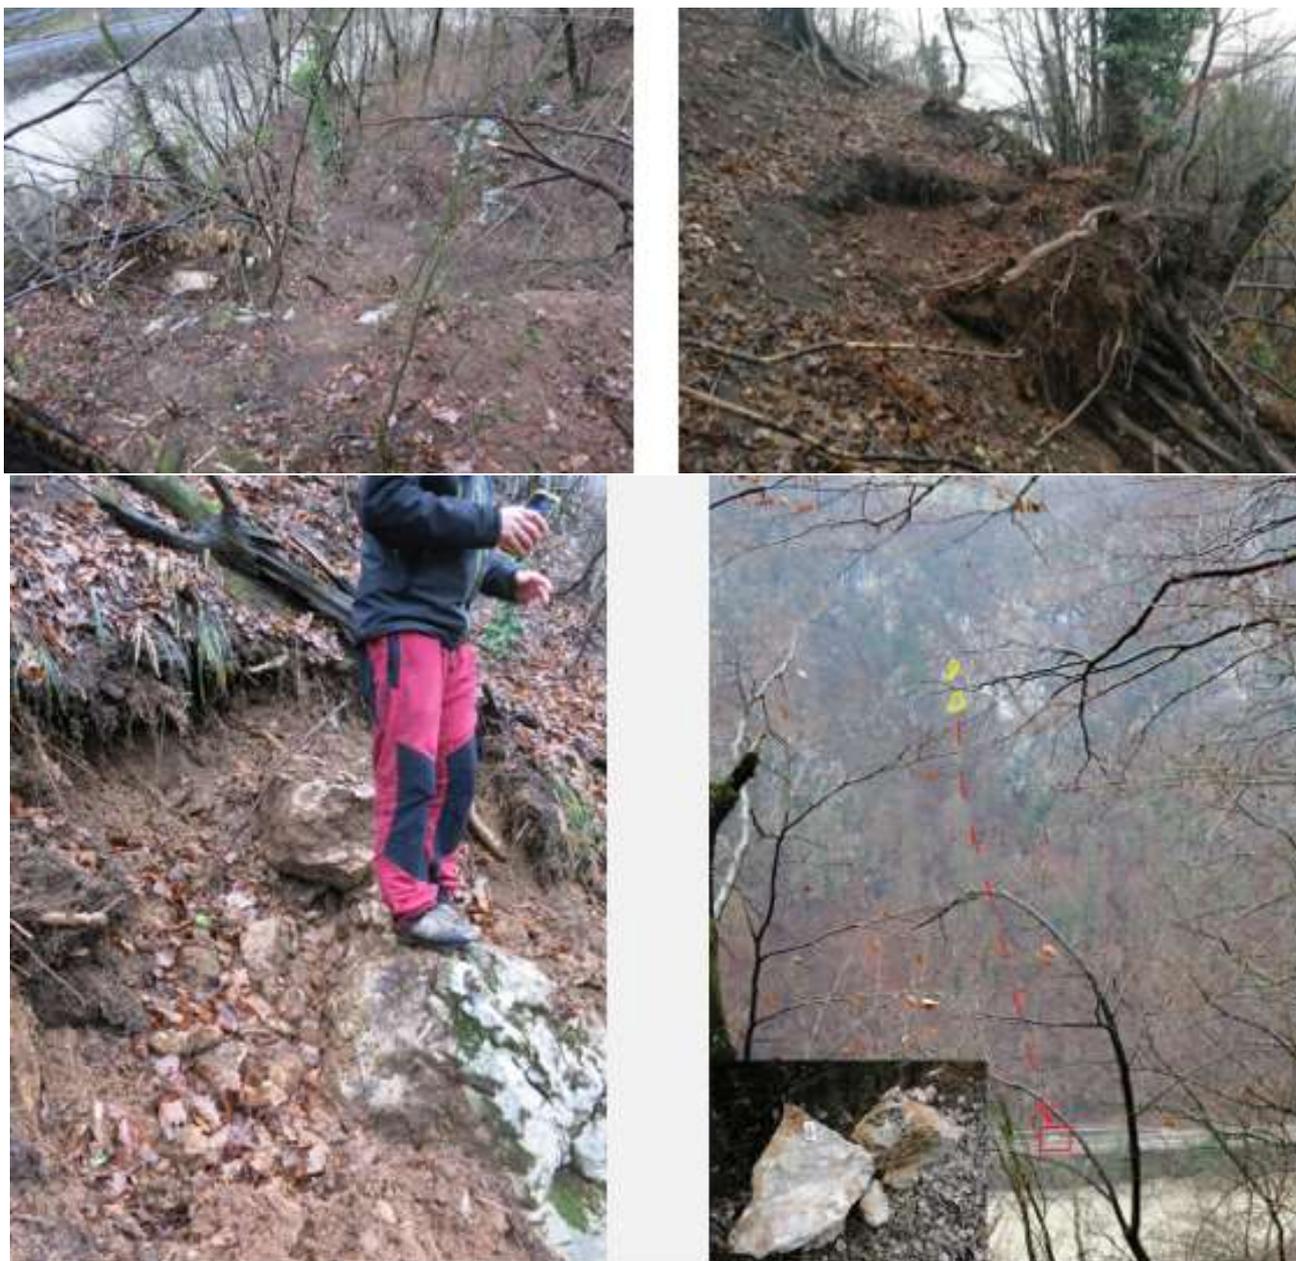
Figure 2 Source area of rockfalls

- the "silent witness" that reveal the past behaviour of the slope and the trajectory of past rock falls (benchmarks on the street, trees, etc.) that can be used to model the runout distance of potential rockfalls
- existing mitigation measures and their usefulness
- rockfall source areas with determination of location, extent, size and shape of rock (Figure 2).
- materials that are potential indicators of rockfall events.

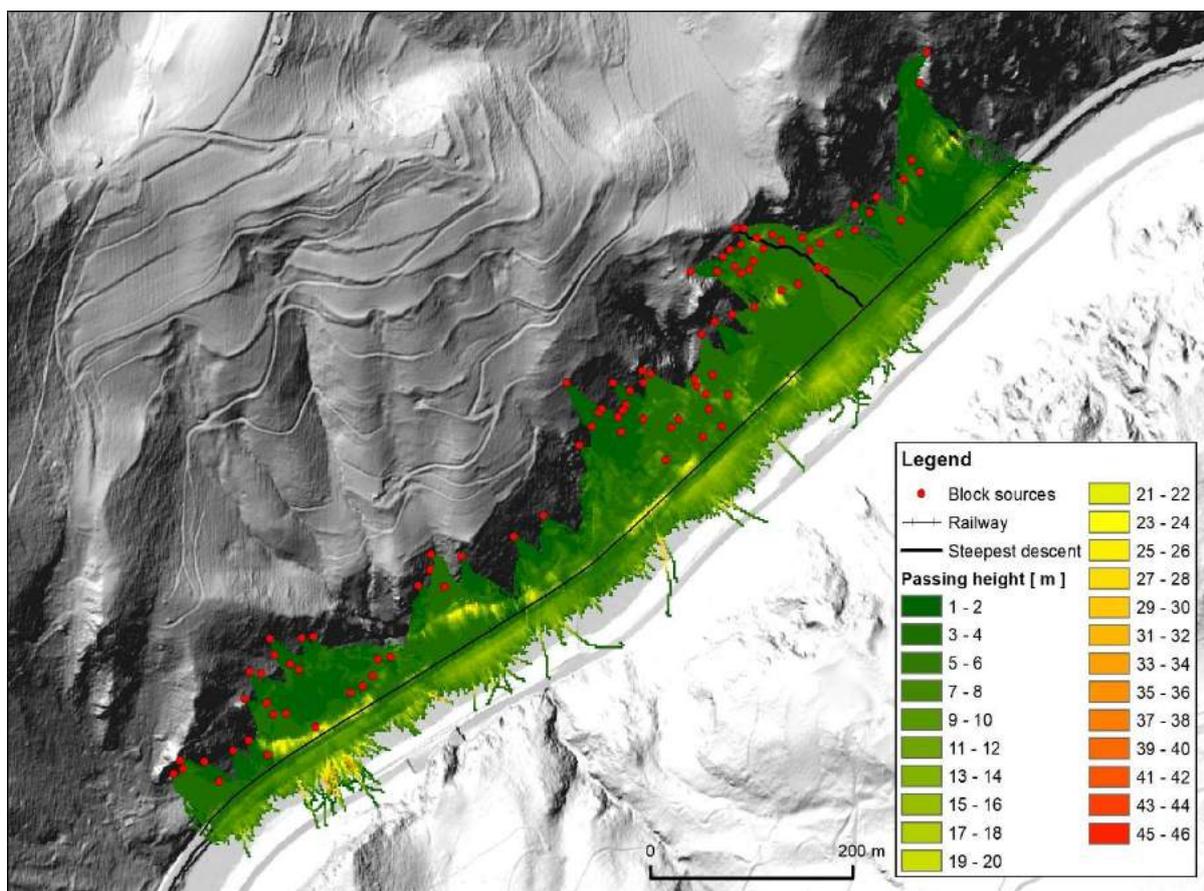
Figure 6 Normal passage heights (95% confidence level) per raster cell for study area

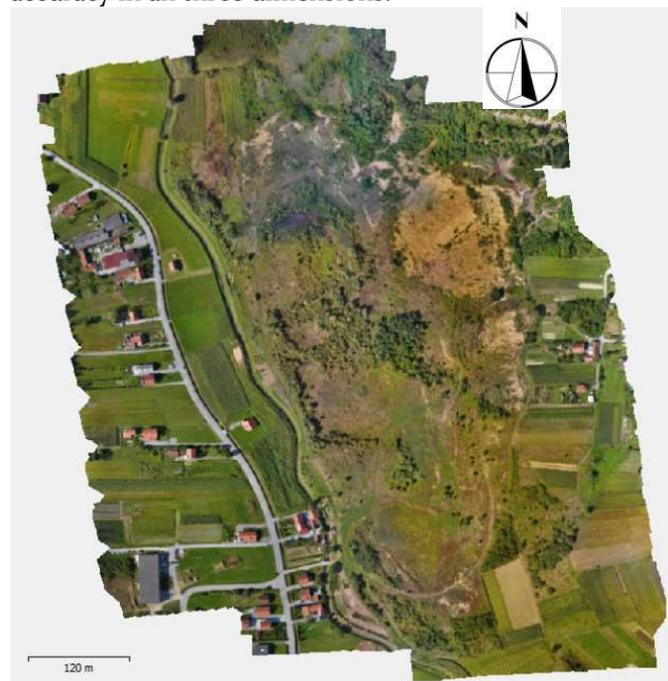
Figure 1 Digital orthophoto (DOF)

Geodetic survey was done with the unmanned aerial vehicle DJI Phantom 4 with a built-in 12 MP camera, which allows high resolution of photos in the formation of stereo pairs, using which are calculated terrain points and finally creates a terrain model, orthophoto, DMR, etc. The survey was done on 08.25.2016. between 13-15 p.m on a relatively sunny day in the presence of windy intervals. The survey covers approximately 50 ha of the surface. For orientation purposes, 9 orientation points have been set up in the national coordinate system (HTRS96 / TM) so that they

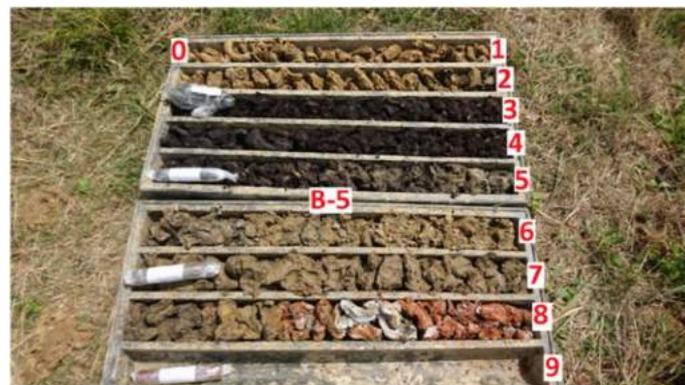
Figure 3 B5 borehole core

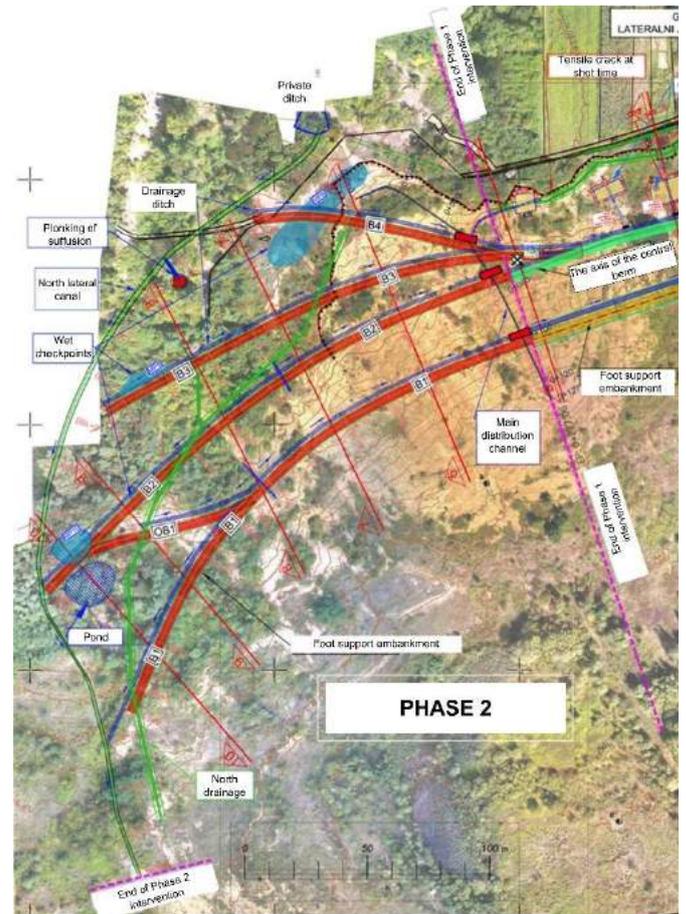
Figure 10 Situation plan II. phases of remedial actions

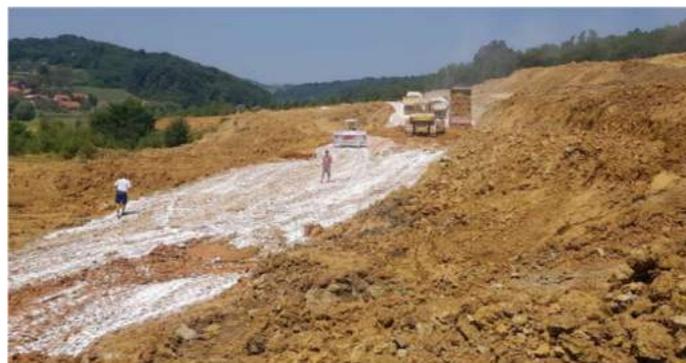
Figure 13 Construction of an embankment during clay pit remediation. A sandy layer of lime is visible, which is compacted with "hedges" before installing the next layer

The required amount of lime per unit area is spread over a loose layer. The spreading is done by a mechanical spreader, which ensures sufficient uniformity of spreading. Compaction was done by hedges, until they were uniformly compacted, thus mixing the binder within the bulk layer (figure 13).

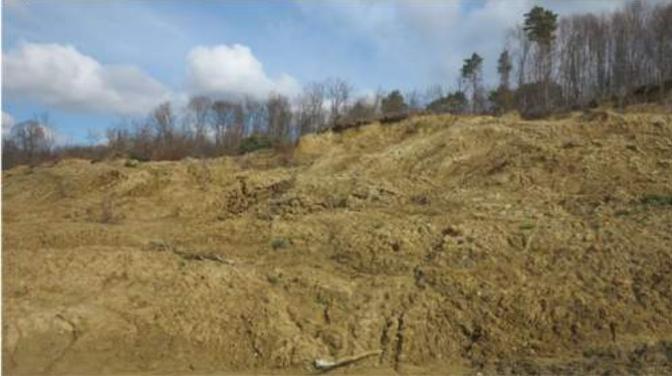
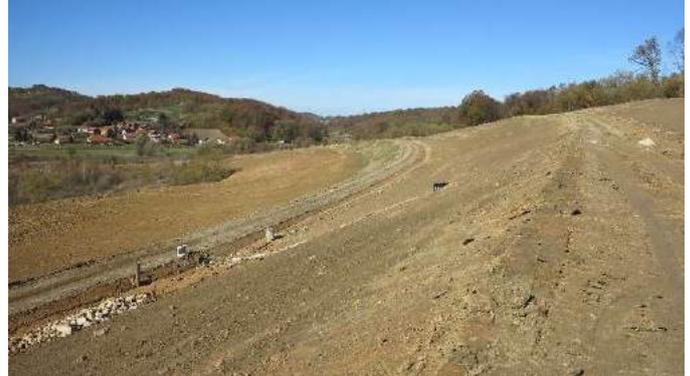
Figure 15 Comparative view of the northern part of the clay pit (a) Prior to remediation work (b) After the rehabilitation works have been carried out (Phase II) - 31.X.2018.

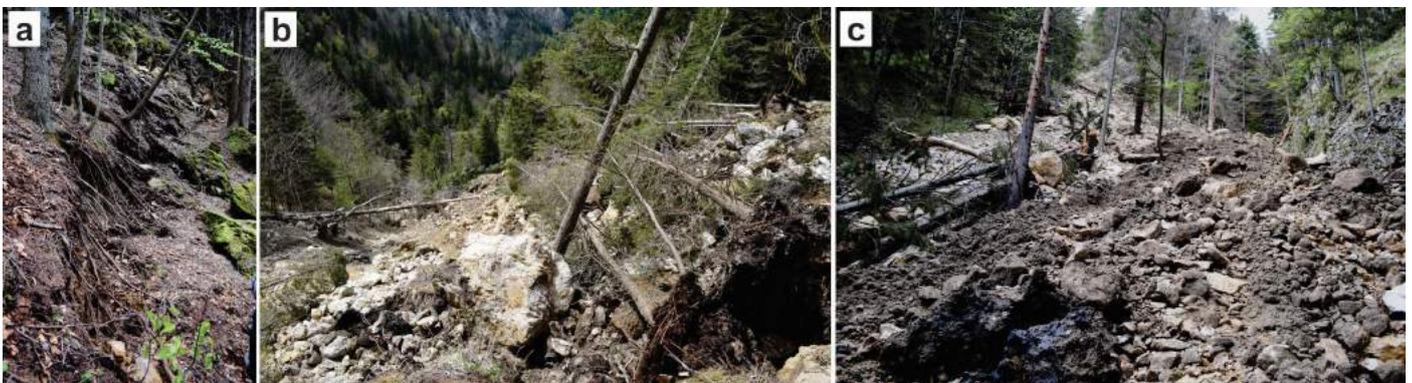
Figure 4 (a) open cracks in the upper part of the Čikla landslide; (b) active movements in the middle part; (c) sediment of the April 2017 debris flow event in the Čikla stream

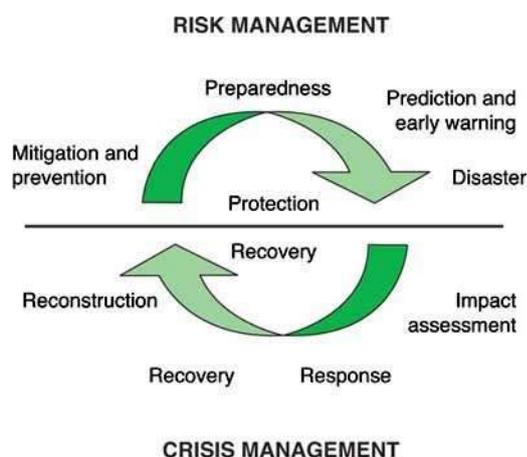
Figure 1 Disaster, risk and crisis management cycle (FAO, 2004)

Figure 1 shows risk management cycle that is divided into two parts, before and after disaster occurrence. The main difference between processes before and after the disaster is that first belong to protection and latter to recovery.

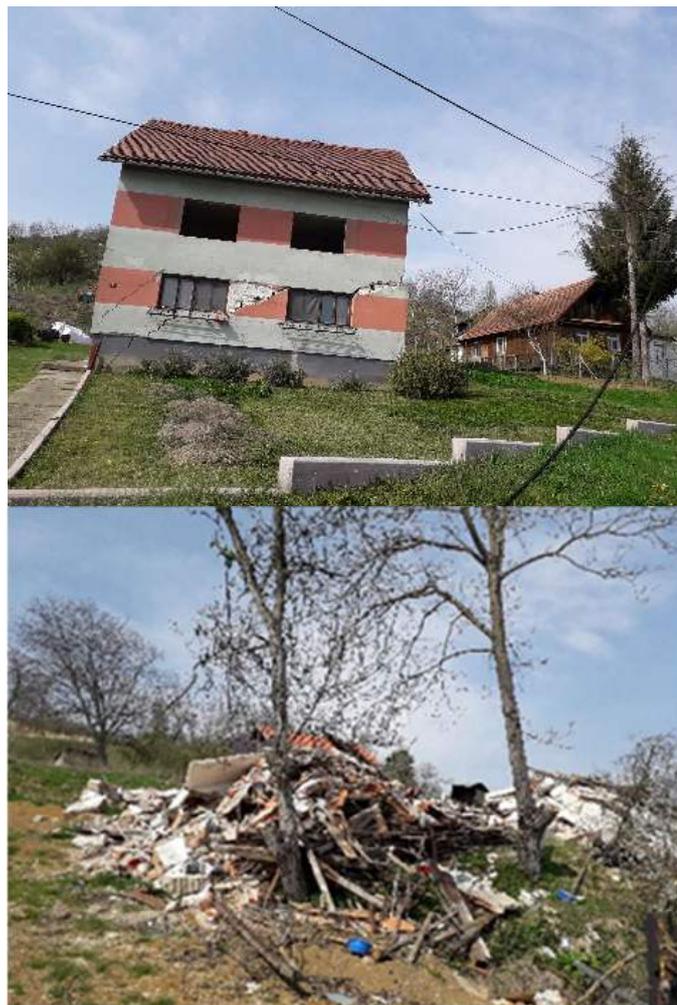
Figure 3 Houses destroyed by collapse of the Hrvatska Kostajnica landslide on 13th March 2018.

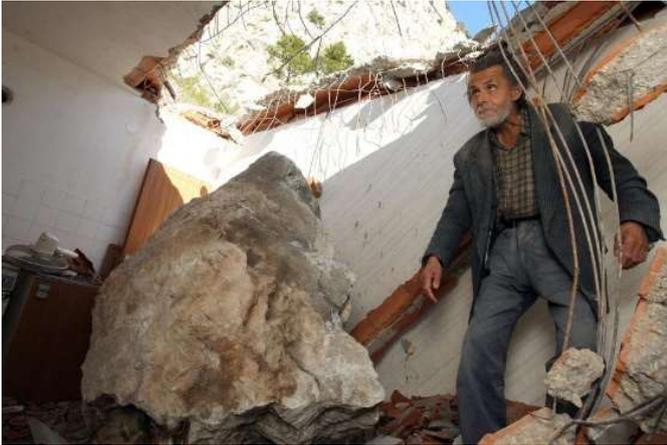
Figure 2 Fallen rock block came through the roof in the house in January 2012 (www.z4sata.hr).

During the last decade more rockfalls that damaged residential houses were registered, as well as numerous rockfalls that reached roads, streets in the town and courtyards without any significant consequence. Unfortunately, there is no rockfall inventory or statistical data about the rockfall volumes, but from the documented data it was found the most usual rockfall volumes were from 0.1 to 5.0 m³. Although all of these rockfalls can be classified as a small, the risk caused by their direct impact on residential houses and infrastructure is very high. Several blocks of a volume of 1.0 to 3.0 m³ fallen from the cliffs hit directly in the houses and came through the roofs and construction in the past (Figure 2) without any injured

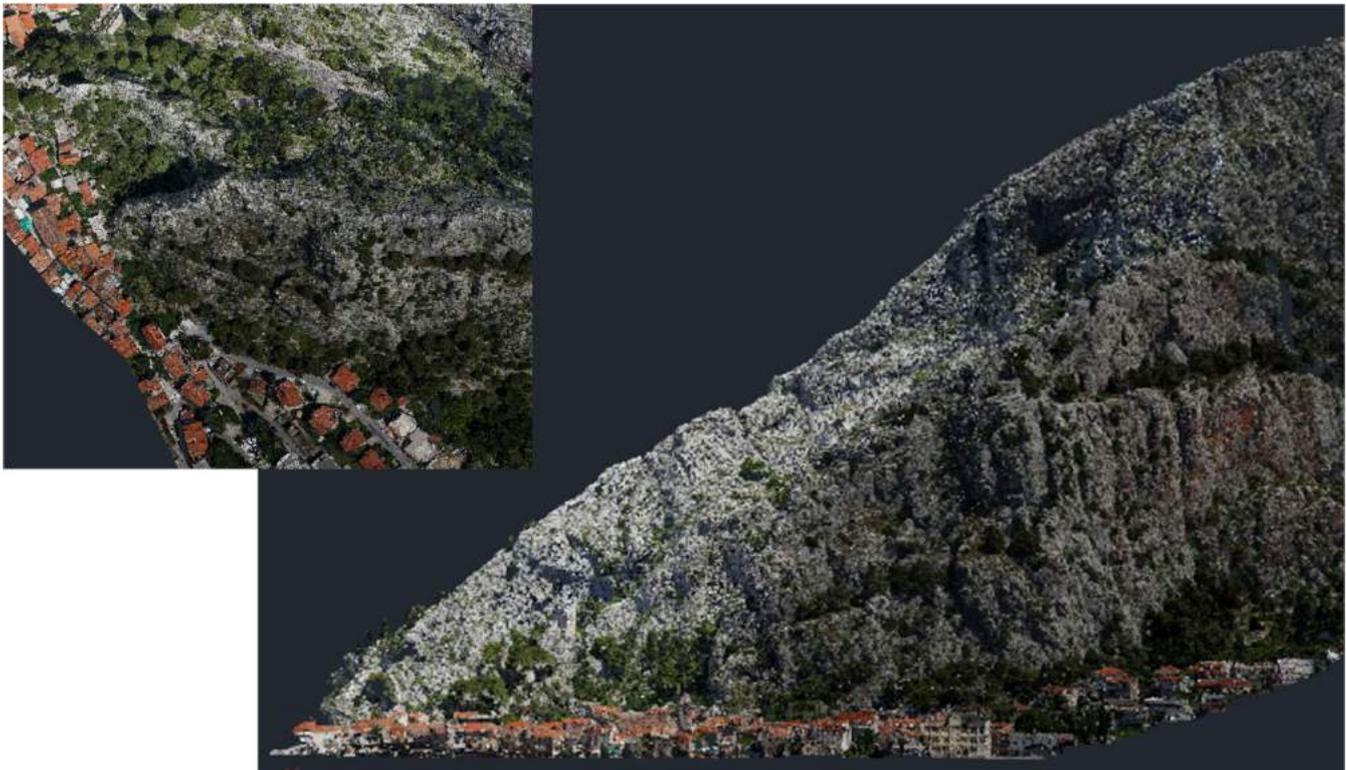
Figure 3 3DPC provided by TLS and SfM techniques. A view at the slope (down); a layout over the middle part of the town (left up).

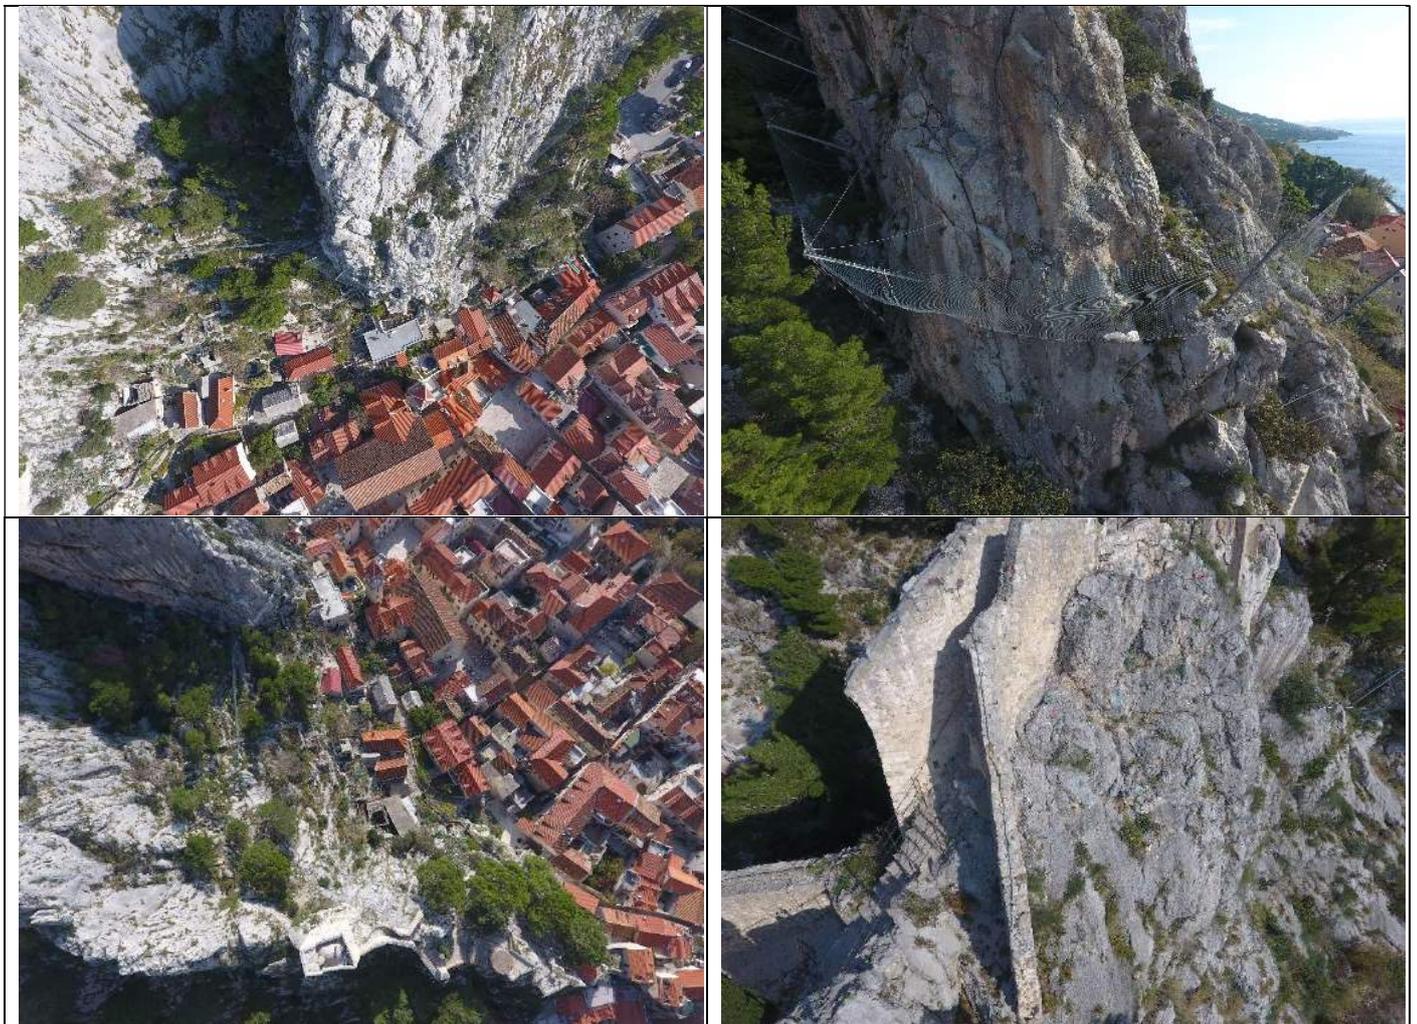
Figure 4 An aerial view at the rockfall protection barriers at limestone slopes above the City of Omiš (left up), a view at the rockfall protection barriers of 2000 kJ capacity at limestone slopes above the center of the City of Omiš (right up); an aerial view at the rockfall protection barrier of 2000 kJ capacity in the ravine above the City of Omiš (left down); a view at the rock mass support systems including rock bolts in combination with steel ropes and steel wire meshes at limestone slope below the Peovica Fortress (right down).

simulation was conducted for each of 8 location of rockfall protection barriers, Additional check was carried out using RockFall software and 2D simulations for critical points identified by 3D simulations. Both 2D and 3D simulations enabled precise defining of rockfall protection barrier positions and their heights and energy absorption capacity. Conducted simulations pointed out on the need for installation of additional rockfall protection barrier at position where rock blocks can leap over a barrier. Position of each barrier pole was precisely determined and defined in high resolution DTM and 3DPC that enabled clear positioning of protection structures in construction stage (Figures 4 and 5). Stability analyses for potentially unstable rock blocks identified in the main design were conducted that defined necessary support system for each analyzed rock block and precisely determined and defined elements of support system in high resolution DTM and 3DPC.
